# Service Bulletin

Bulletin No.: 09-07-30-012F

Date: October, 2012

**Subject:** No Reverse, 3rd or 5th, Check Engine Light Illuminated, DTC P0776  
(Replace 3-5 Reverse Clutch Plate (Waved))

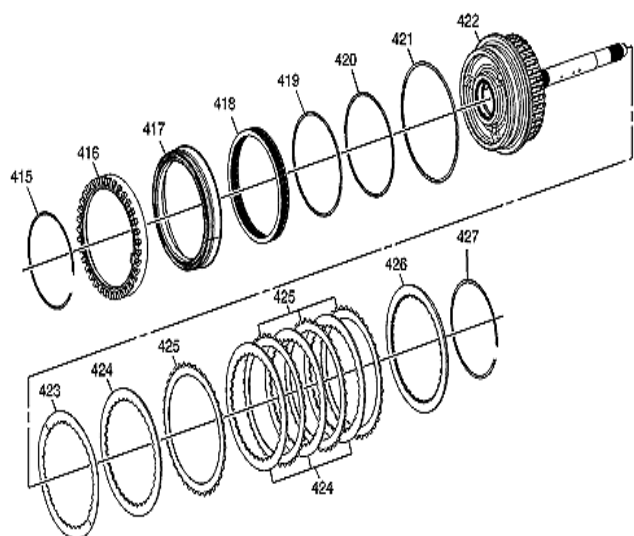
2584818

A broken 35R wave plate can generate varying amounts of debris inside the transmission. In most cases this debris has not passed through the pump fluid filter (201) damaging the pump, valve bodies or torque converter. This debris can be cleaned and the transmission successfully repaired.

A new 3-5 reverse clutch plate (WAVED), P/N 24254103 (423), has been released to address this condition. Refer to SI for the appropriate repair instructions.

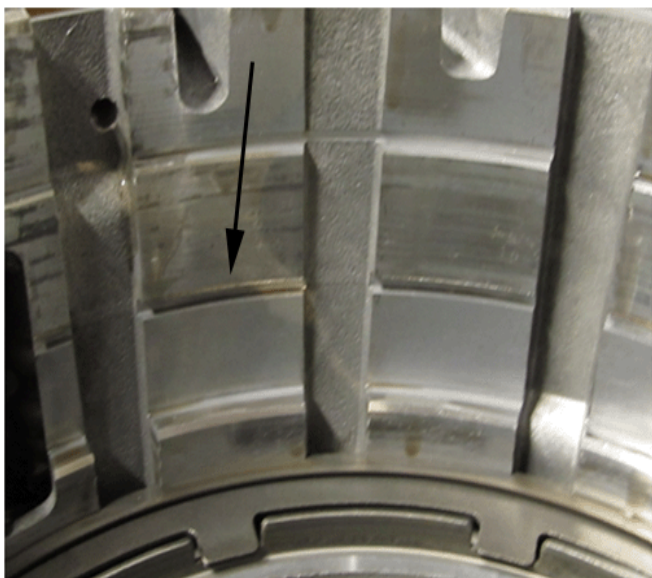
2753500

1. After removing the transmission from the vehicle, remove the case cover assembly (35). Inspect the case cover for damage. This part is serviced and can be replaced if it is damaged.
2. Remove the 35R/456 clutch housing assembly (422) and inspect it for a broken 35R wave plate (423).
3. Inspect the case (21) for damage caused by a broken wave plate as shown below.

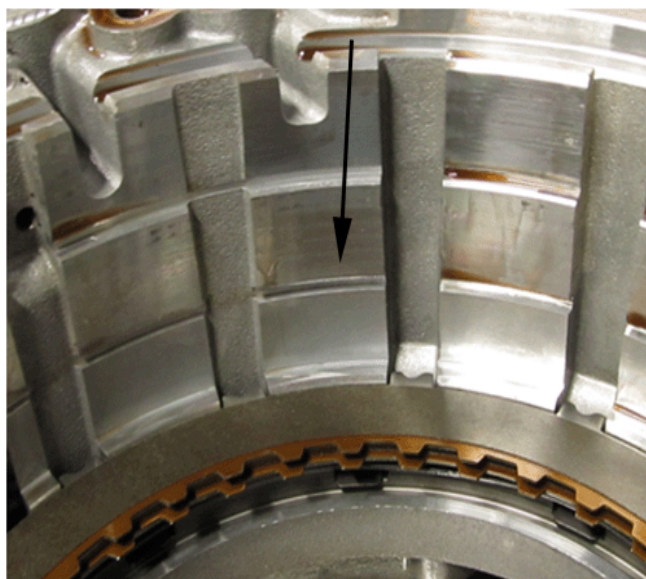
2753502

- The snap ring groove, which is well below the 3-5-R wave plate area, is unlikely to be damaged. It should still be checked to verify the snap ring is fully seated and to be securely retained.

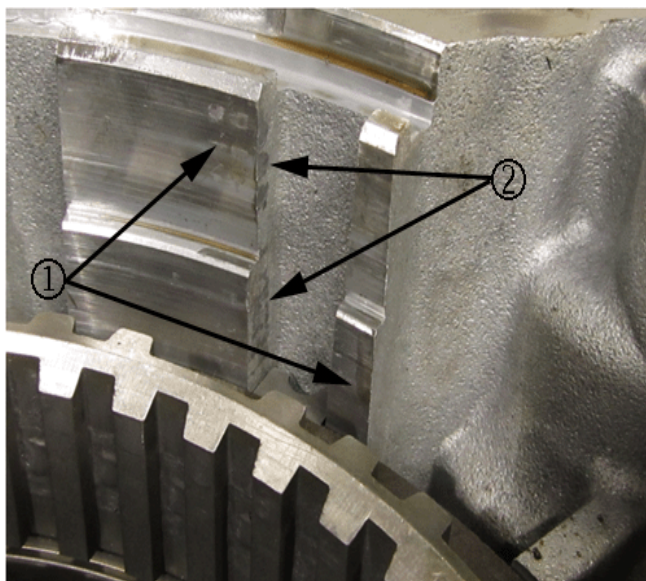
2753503

- Peening or wear of the face or edge of the case lugs that engage the steel clutch plates is normal and not cause for transmission replacement.

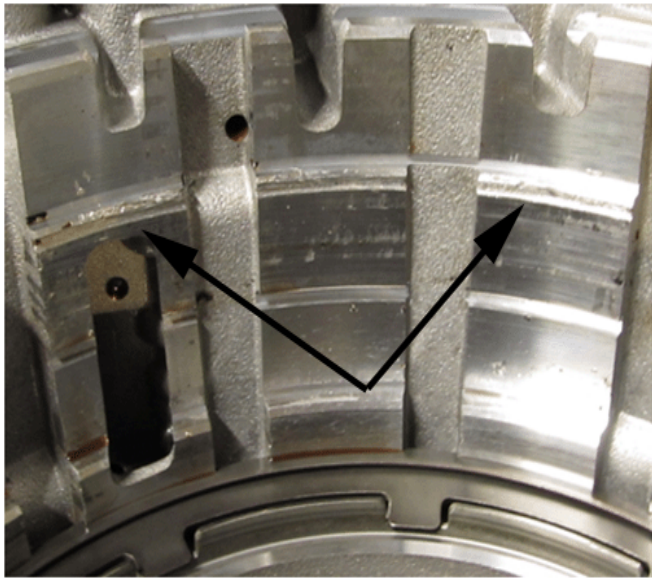
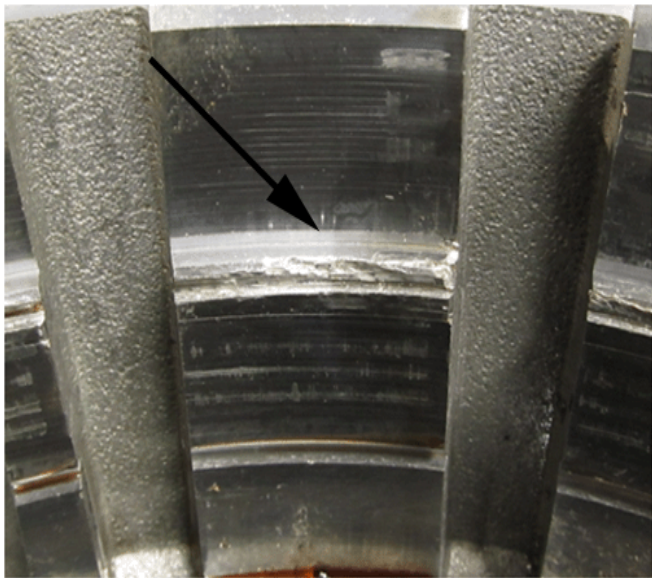
- Some degradation of the shelf for the 2-6 backing plate is acceptable as long as the plate can lie flat. A raised burr that prevents this can be removed using a de-burring tool, file or some other abrasive.
4. Remove the control valve body cover (1), control solenoid (w/body and TCM) valve assembly (15) and filter plate assembly (16).
  5. Inspect the filter plate assembly (16) for the presence of metallic debris on the screens.
    - If there is no debris on the screens, the pump fluid filter was effective and there is no debris in the pump or torque converter. Therefore the pump, torque converter and valve body do not need to be replaced. The transmission should be repaired.
    - If there is debris on the screens, the pump and torque converter should be inspected further. Refer to SI procedure Transmission Fluid Pump

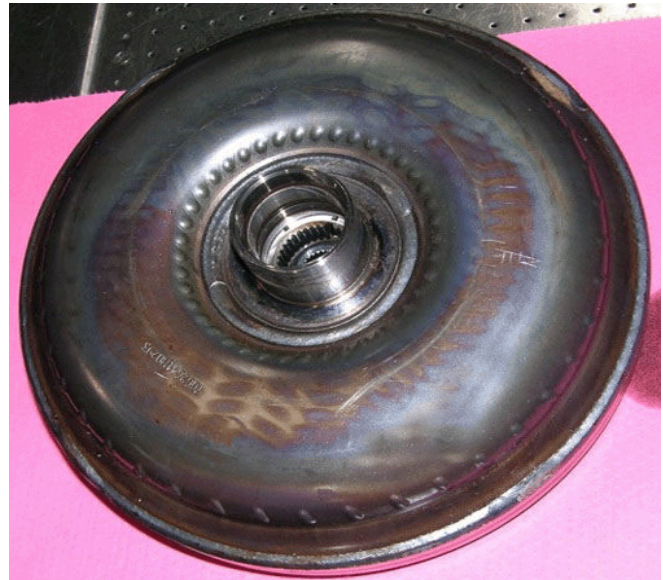
2739303

**Note:** The manufacturing process of the torque converter can cause the hub side to appear blue or darker in color while the lug side is a natural metal color. If the torque converter appearance is like this and no other reason is observed per the SI procedure for torque converter diagnosis, then the torque converter does not need to be replaced.

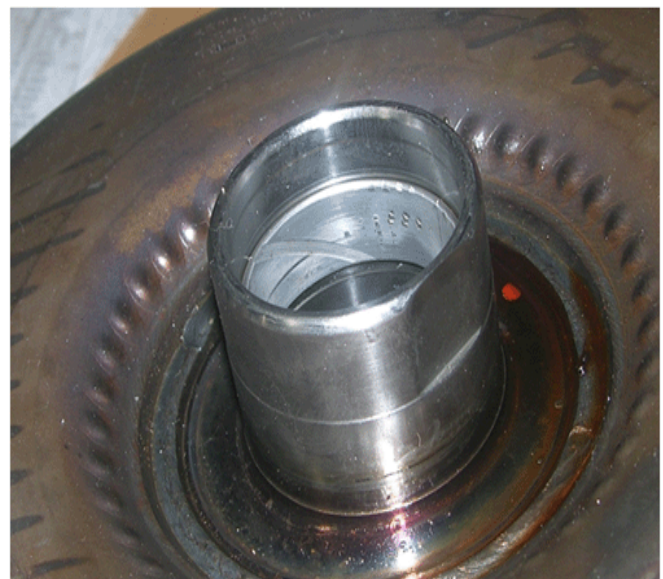
2753510

Marks such as these on the torque converter bushing are not a reason to replace the torque converter. They usually occur during removal of

the transmission from the vehicle or removal/ installation of the torque converter on the transmission and are caused by the bushing contacting the front differential transfer drive gear support (208) or the 3-5-R housing (422).

Also the marks are below the surface of the bushing and will not interfere with proper operation, however if there is a raised burr it can be removed with a de-burring tool or other abrasive.

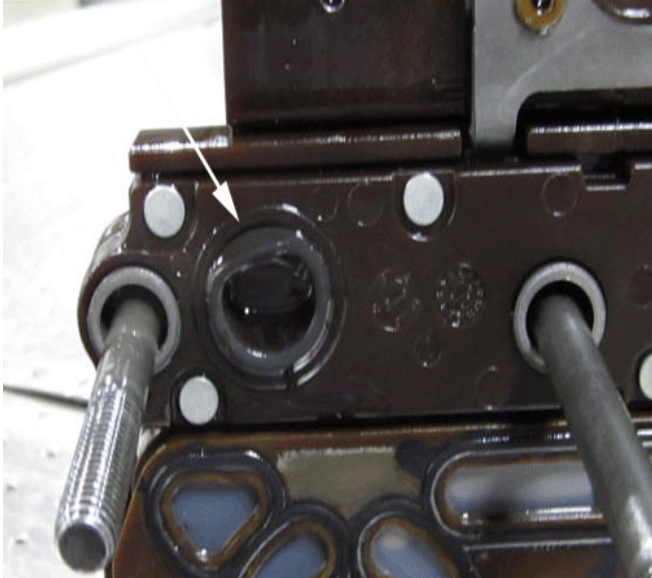
2850322

6. Inspect the control solenoid (w/body and TCM) valve assembly (TEHCM) (15) pressure switches. The O-ring seals may be deformed but if they are attached, as shown above, the TEHCM should not be replaced; it should be reused. Deformed seals do not affect switch performance.

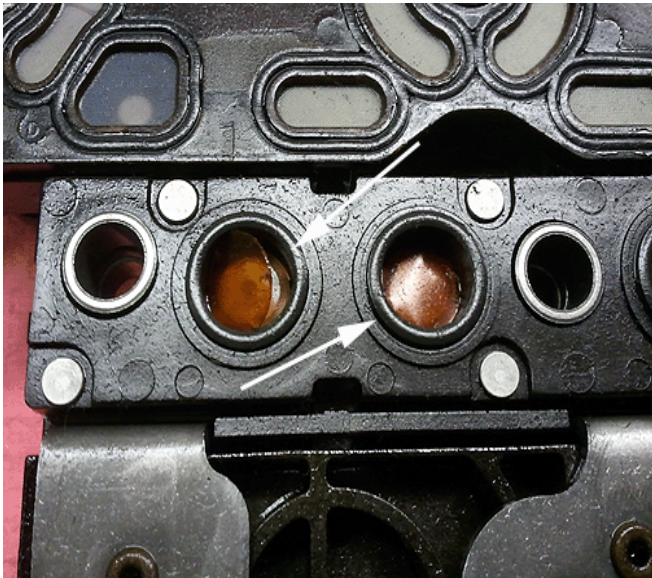
2630114

If any of the switch membranes are damaged, as shown above, the TEHCM must be replaced.

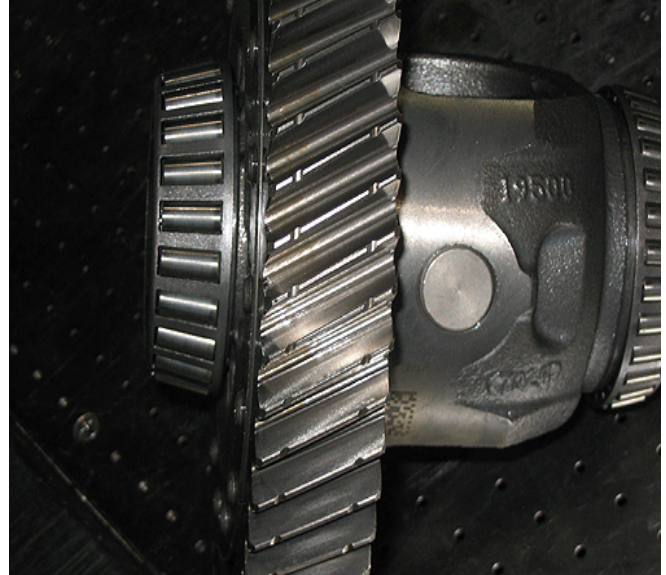
2584822

**Notice:** The front differential carrier assembly (31) teeth are marked with notches to identify gear ratio (see picture above). Do not confuse these marks with tooth damage. Do not replace the gear for this condition.

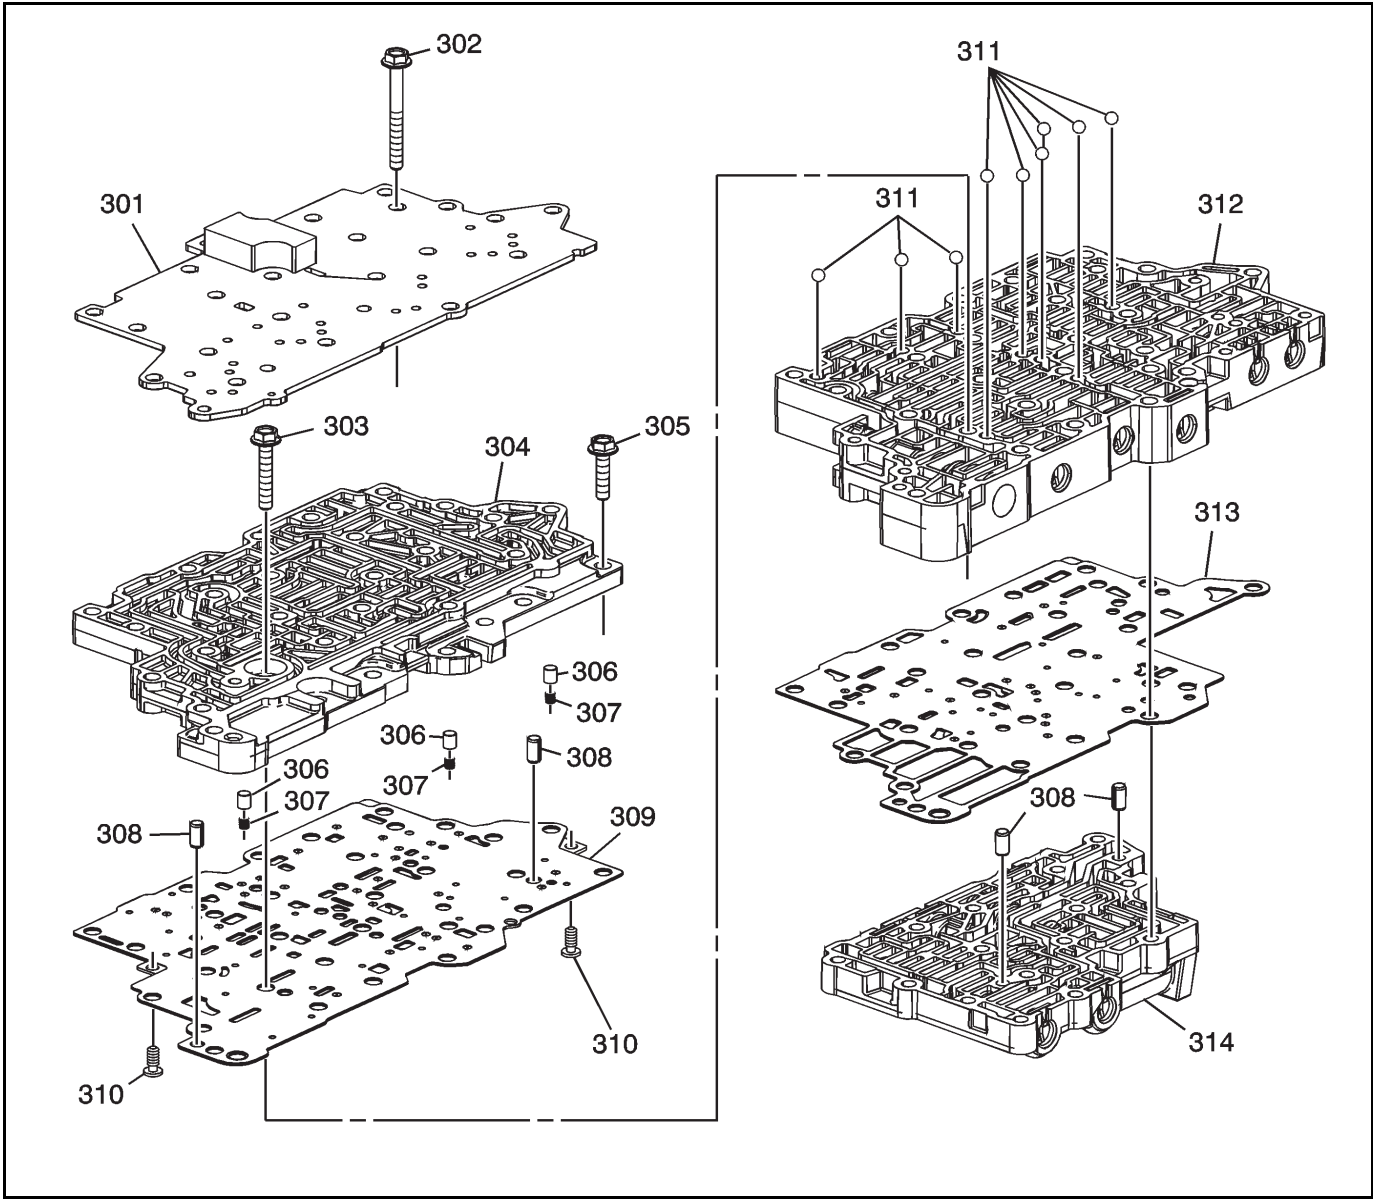
**Important:** 2007-2008 applications – when assembling these transmissions, inspect the control valve channel upper plate (301) to make sure that it contains the slot as indicated above. Plates installed that do not include this slot may result in DTCs.
