**NUMBER:** 08-056-12 REV. A

Information On New Radio Systems: Sales Code RA1, RA2, RA3, or RA4

2013 (DS) Ram 1500 Pickup **\*\* (U.S. Market Only) \*\***

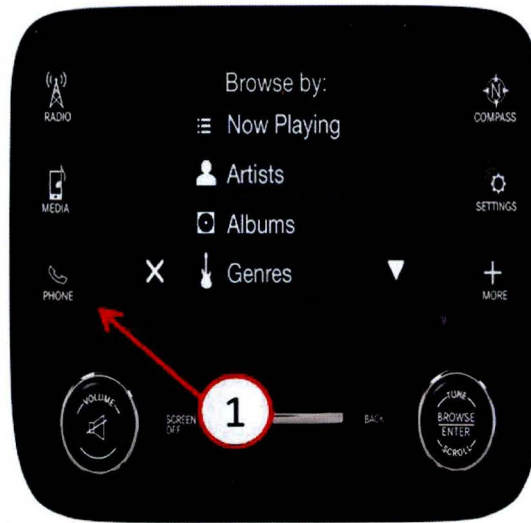
**Fig. 2 Radio sales code RA2**

1 - RA2 radios will have this phone button.

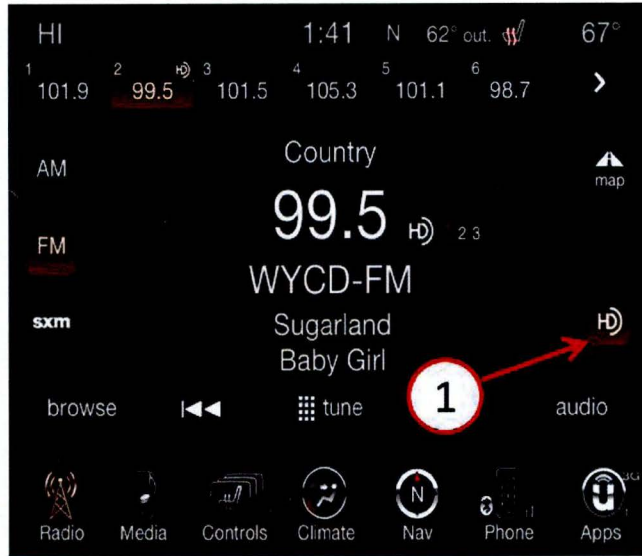
**Fig. 4 How to tell if the radios is an RA4**

1 - RA4 radios will have this HD) symbol.
