Service Bulletin

SUBJECT: Service Update for Inventory Vehicles Only
Incorrect Material Used for Transmission O-Ring
Expires September 30, 2013

MODELS: 2012-2013 Buick Regal
2013 Buick LaCrosse
2013 Chevrolet Malibu
Equipped with 6-Speed Hybrid Automatic Transmission (MHH)

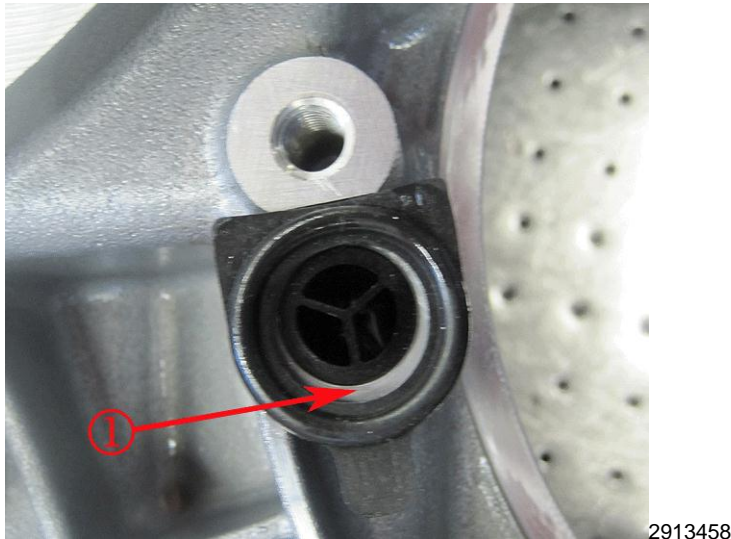
2913458

Note: The fluid inlet pump seal (1) may be torn as shown in the photo below.

1. Install a new A/Trans Auxiliary Fluid Inlet Pump Seal (8).
2. Install the Fluid Pump Assembly (6).
3. Install Fluid Pump Bolts M8 x 33 (5) (Qty: 8)
Tighten to 10 N·m (89 lb in) then rotate the bolt an additional 45 degrees
4. Install Front Differential Carrier Baffle (2).
