Service Bulletin

SUBJECT: Service Update for Inventory and Customer Vehicles
Rear Seat Removable Arm Rest Rattle
Expires with Base Warranty

MODELS: 2013 Chevrolet Volt
Equipped with Removable Arm Rest (DA1)

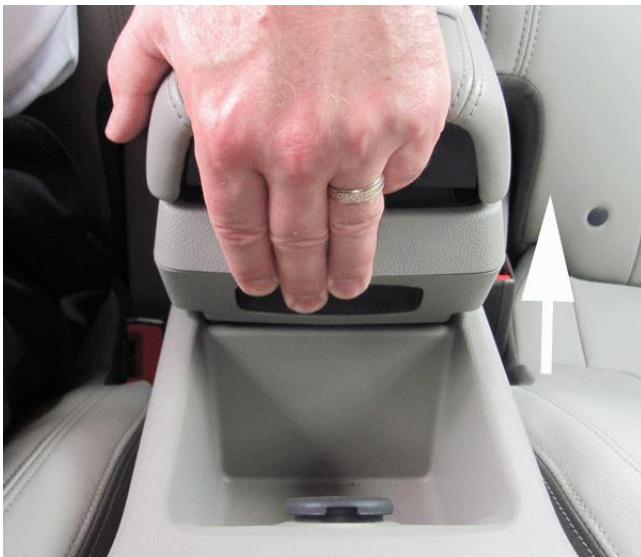
2967217

This bulletin provides a service procedure to inspect and ensure that the removable arm rest is properly latched to the rear floor console on **certain** 2013 Chevrolet Volt vehicles. The arm rest is attached to the rear floor console by a latch. On some vehicles, the opening in the floor console may be too large. If this condition exists, the customer may hear a rattle sound. Under certain vehicle conditions, the potential exists for the removable arm rest to separate from the console. Dealers are to replace the rear floor console if the removable arm rest is not properly attached.

1. Locate the rear floor console.

2. Determine if the rear armrest latches properly to the rear floor console by lightly pulling up on the armrest. Do NOT attempt to pry or separate the armrest from the console with great force.
 - If the rear armrest remains latched and is attached to the rear floor console securely, no further action is required.
 - If the rear armrest does NOT remain latched and is not attached to the console securely, remove and replace the lower portion of the rear floor console. The removable armrest can be reused. Refer to *Rear Floor Console Replacement* in SI.
