Service Bulletin

SERVICE UPDATE

SUBJECT: Service Update for Inventory Vehicles Only
Steering Wheel Doesn't Heat, Horn Continuous, Battery Drain
Expires December 31, 2013

MODELS: 2013 Cadillac XTS

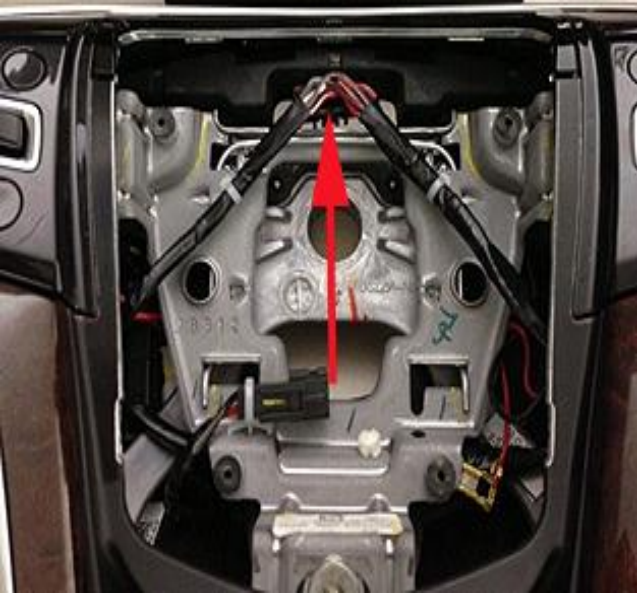
2966068

2. Inspect the steering wheel metal base plate.
 - If you see a RED or BLACK line under the airbag retention spring between the left and right branches of the main wire harness, the steering wheel has already been reworked. No further rework is required. Inspect the wiring and ensure there is no damage to wires and reposition the heated steering wheel wire harness as shown in UVD step #5. Reinstall the airbag module into the steering wheel.
 - If no black or red indicator is found, proceed to step 3.

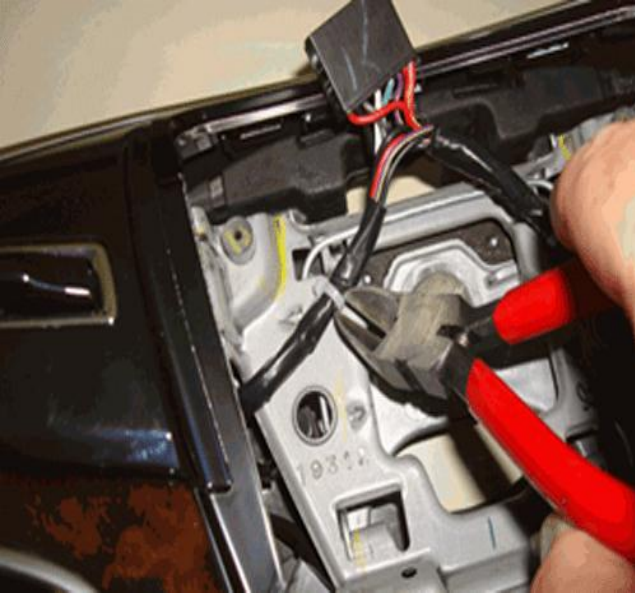
2966071

- Measure both the left side and right side harness length from the white retaining clip (wire tie) to the center of the connector (where white wire enters). The wire length should be measured from a straightened wire. The measurement should be between 50 mm and 63 mm in length for both left and right side.
- If either side measures less than 50 mm or more than 63 mm, proceed to step 4. If both sides are within the target measurement, proceed to step 5.

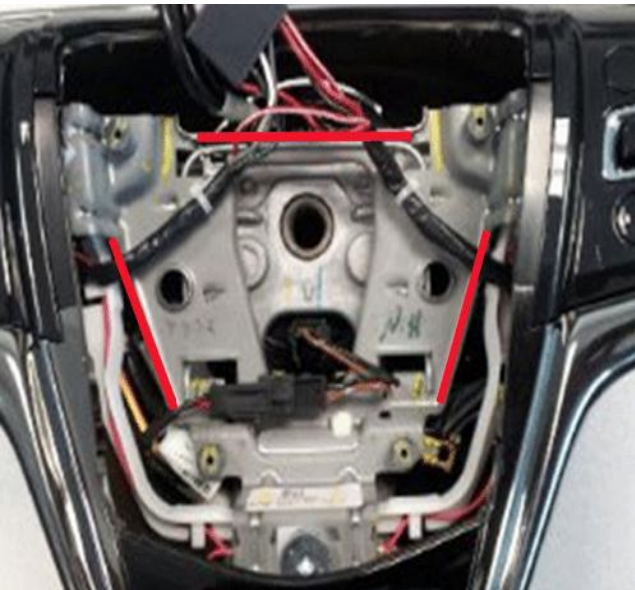
2966073

5. Carefully inspect the wires for damaged (missing) insulation. This damage is caused by the wiring making hard contact with the sharp metal edge of the stamped steel horn plate.
 - 5.1 If only the insulation is damaged, apply two light coats of *Kent Industries Liquid Vinyl Tape, Part # 99491 or the equivalent, to the wire where the insulation is nicked or missing. Proceed to step 6.
 - 5.2 If the insulation and the conductor (wire) are damaged, replace the affected harness. After the harness has been replaced, continue with step 6.
