SUBJECT: Service Update for Inventory and Customer Vehicles
Starter Motor Damage Due to Positive Battery Cable and Starter Solenoid
Terminal Contact
Expires with Base Warranty

MODELS: 2013 Chevrolet Sonic
U.S. Vehicles Only

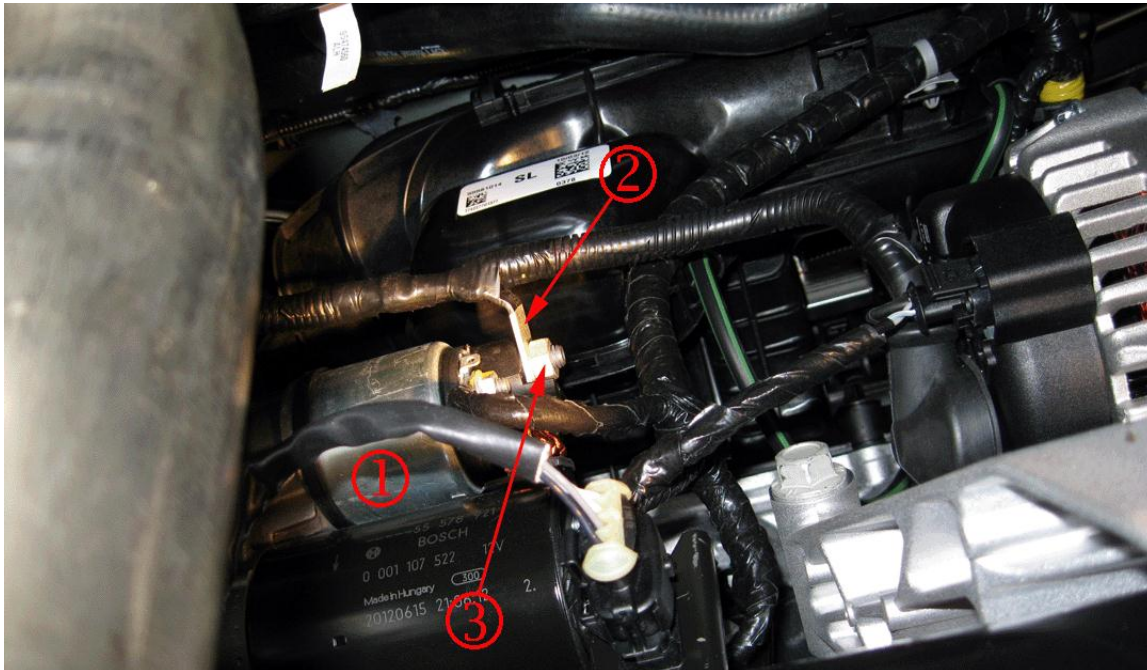
3. Locate the starter solenoid (1), positive battery cable terminal (2) and positive battery cable fastener (3).
