SERVICE UPDATE

SUBJECT: Service Update for Inventory and Customer Vehicles
Front Seat Cushion Trim Retention
Expires with Base Warranty

MODELS: 2013 Cadillac XTS

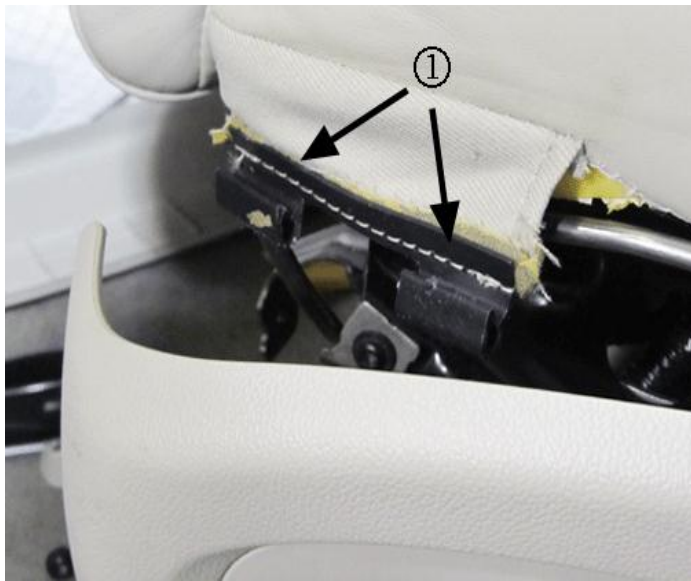
2910863

Note: Some seats may have a single hog ring (1) at either or both front corners of the seat.

- For the outboard corner repair, it will be necessary to remove this hog ring to fully release the J-channel from the seat frame.
- For the inboard corner repair, leave the existing hog ring intact.
