Recall Bulletin

PRODUCT EMISSION RECALL

SUBJECT: Knock Sensor Wiring Harness Connections Reversed

MODELS: 2013 Chevrolet Malibu
Equipped with 2.5L Engine (LCV)

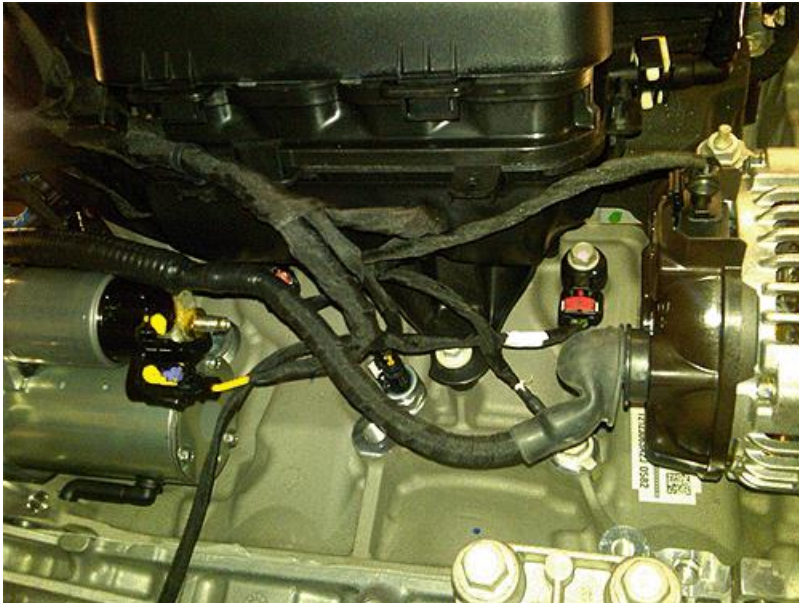
Note: The wiring harness lead that was previously connected to the knock sensor 1 (RH) will now be connected to knock sensor 2 (LH). The lead that previously connected to knock sensor 2 (LH) will now be connected to knock sensor 1 (RH). When the connector swap is completed, the knock sensor wire colors will be as follows:

- Knock Sensor 1 (RH, generator side) – Violet/Gray & Black/Yellow
- Knock Sensor 2 (LH, starter side) – White/Gray & Black/Gray

7. To provide additional harness length to allow the connector to reach the other sensor, open the wiring harness by removing tape from the branch of the RH knock sensor, as necessary. Use a sewing seam ripper, available from sewing supply stores, in order to cut open the harness in order to avoid wire insulation damage.
