# Recall Bulletin

## F/CMVSS NONCOMPLIANCE RECALL

**SUBJECT:** Possible Missing Secondary Hood Latch

**MODELS:** 2010-2012 Chevrolet Colorado  
2010-2012 GMC Canyon

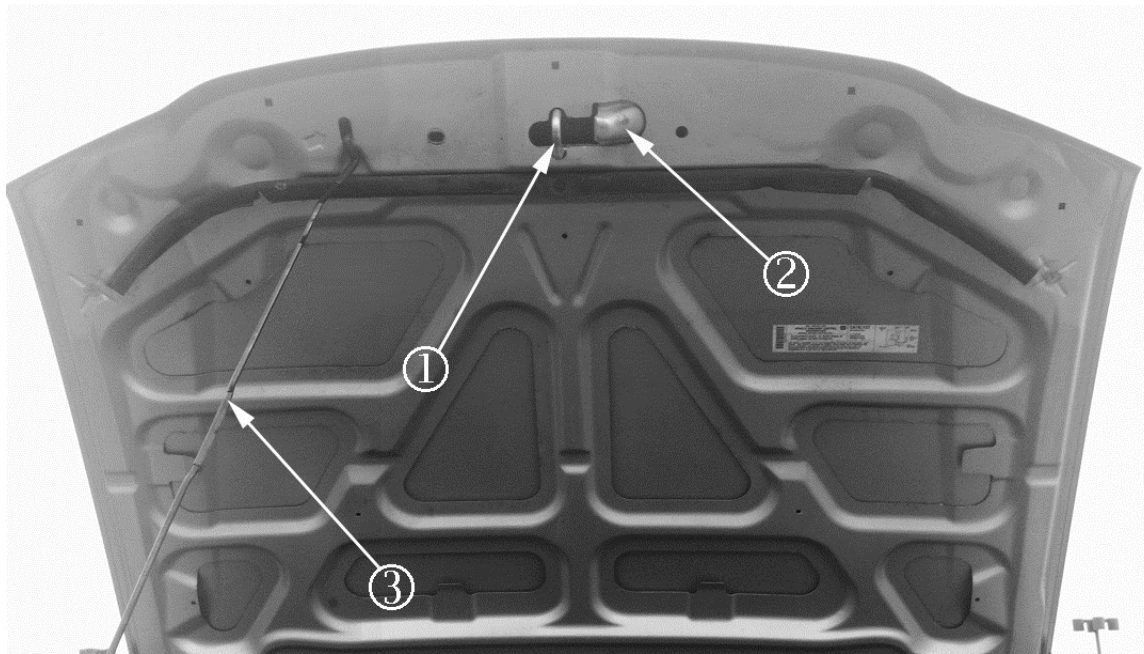
3228827

1. Lift the vehicle hood.

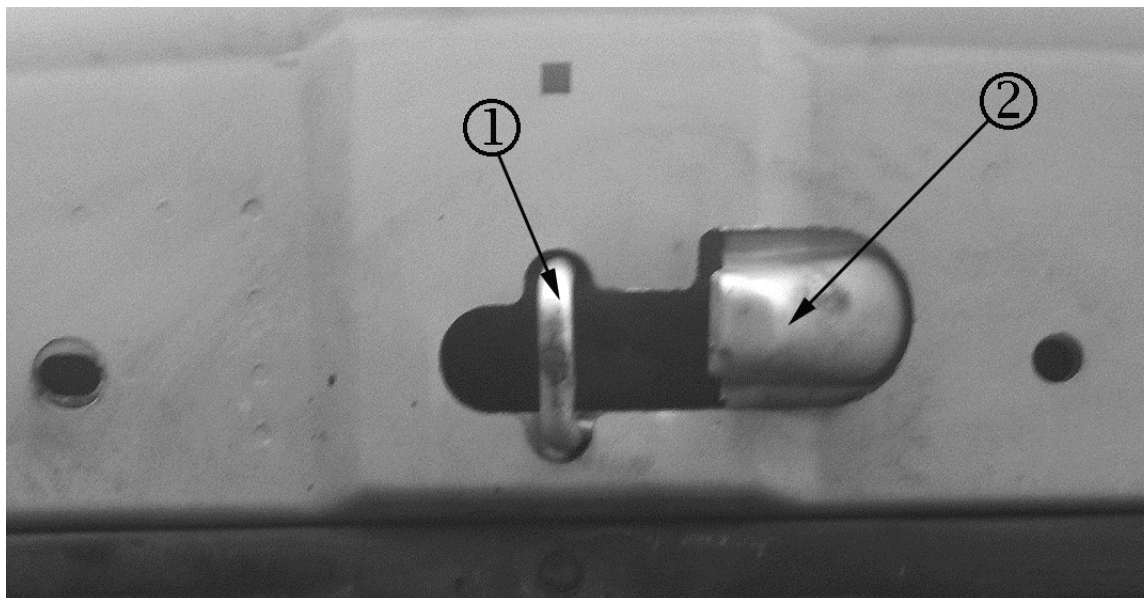
3228830

2. Release the hood prop from its retainer and put the hood prop into the slot in the hood (3).
3. Locate the primary (1) and secondary (2) hood latches. Refer to the illustration.

4. Determine if the hood is assembled with a secondary latch (2).
  - If the vehicle hood is assembled with a secondary latch, no further action is required. Lift the hood to relieve pressure on the hood prop. Remove the hood prop from the slot in the hood and return the prop to its retainer. Lower the hood 25 to 30 cm (10 to 12 in) above the vehicle and release it to latch fully. Check to make sure the hood is closed and repeat the procedure if necessary.
  - If the vehicle hood is NOT assembled with a secondary latch, remove and replace the hood. Refer to *Hood Replacement* in SI for hood removal and installation instructions.
