# TECHNICAL BULLETIN

UPS4812-5bNAS1

### Update Prior to Sale: Front Subframe Bolts Incorrectly Torqued

XF (X250)

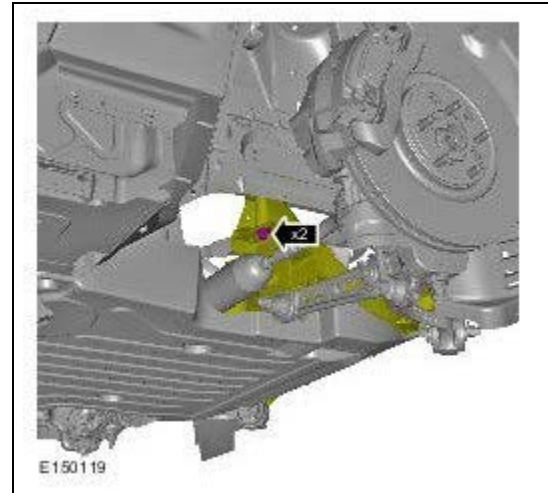
**Situation:** A concern has been identified with a limited number of 2012 model year XF vehicles where the front subframe rear bolts have the incorrect torque applied.

**NOTE: Right-hand shown; left-hand similar.**  
Remove and discard the front subframe right-rear bolt.

**NOTE: Remove and replace only one bolt at a time.**

4. Install a new front subframe right-rear bolt.
  - Tighten the new bolt to 80Nm + 240° (59 lbf ft + 240°).
5. Remove and discard the front subframe left-rear bolt.
6. Install a new front subframe left-rear bolt.
  - Tighten the new bolt to 80Nm + 240° (59 lbf ft + 240°).
7.
