# TECHNICAL BULLETIN

K128NAS1  
25 SEPT 2012

### Service Action: Right-Hand Rear Fog Lamp

XK (X150)

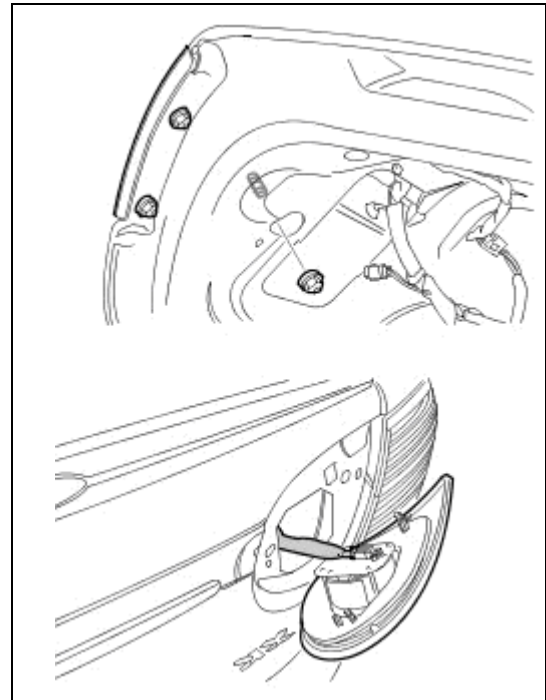
**Situation:** A limited number of 2012 model year Jaguar XK vehicles may have been manufactured away from process and in some cases the right-hand (RH) rear fog lamp may be incorrectly welded.

1. Convertible only: refer to Workshop Manual section 501-05 and remove the luggage compartment lid trim panel.
2. Coupe only: refer to Workshop Manual, section 501-05 and remove the liftgate lower trim panel.
3. Remove the right-hand (RH) reverse / fog lamp:
  - Remove the three (3) plastic nuts.
  - Disconnect the electrical connector.
