NUMBER: 23-022-12 REV. A

Knocking Sound From Instrument Panel Area Near The A-Pillar

2011 - 2012 (WD) Durango
****2011 - 2012 (WK) Grand Cherokee****

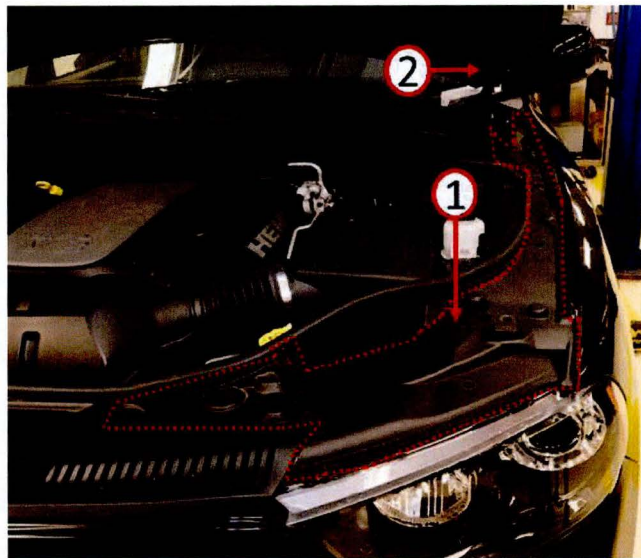
Fig. 1 Remove Fender Closeout

- 1 - Upper Fender Closeout Panel
- 2 - Hood Hinge (Driver Side)

5. Road test the vehicle to ensure the repair eliminated the concern.
6. Was an audible buzz, squeak, or rattle (BSR) or knocking sound heard?
 - a. Yes >>> Proceed to [Step #7](#).
 - b. No >>> Return the vehicle to the customer.
7. Open the hood and remove the driver side upper fender closeout panel ([Fig. 1](#)).

10. Reinstall the corner cowl to fender closeout (Fig. 2) and upper fender close out panel (Fig. 1).

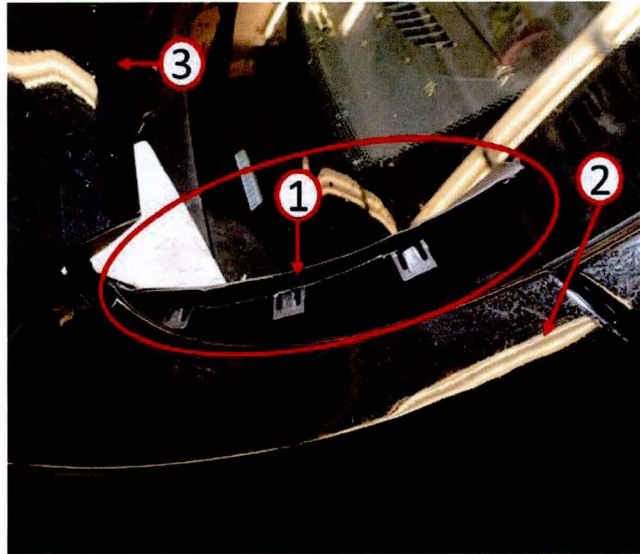
Fig. 2 Remove Cowl Corner To Fender Seal

1 - Cowl To Fender Closeout/Seal (Lower Right Corner of Windshield)

2 - Driver Side Fender

3 - Rear Corner of Hood

-
8. Pull back the corner of the cowl to fender closeout ([Fig. 2](#)).

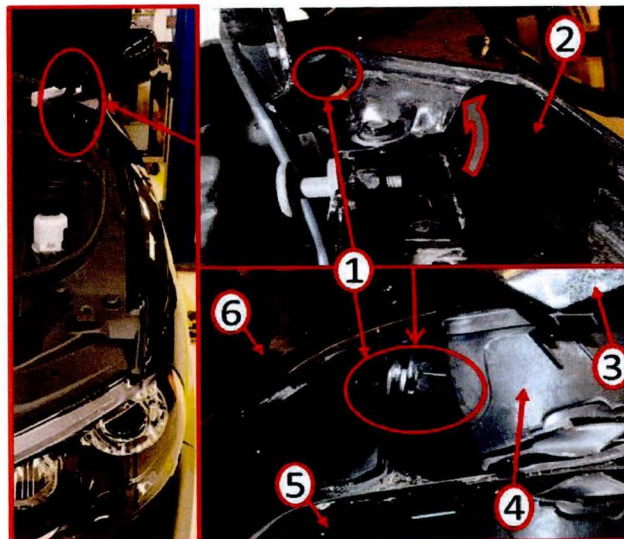
Fig. 3 Hood Hinge Pivot Bolt Removal

An audible buzz, squeak, or rattle (BSR) or knocking sound may appear to be coming from the instrument panel (I/P) area at or near the front leading edge of the A-pillar. The noise may actually be caused by an improperly adjusted hood hinge. The hood hinge can be checked in the closed position by grasping the hood near the rear corners at the hinge and lifting up and down. If excessive motion and/or a knocking sound is produced or the customer describes the symptom, perform the Repair Procedure.

- 1 - Hood Hinge Pivot Bolt (Driver Side Hood Hinge)
- 2 - Hood Pivot Bolt Access (Rear of Upper Fender/Front View)
- 3 - Hood (Rear Corner)
- 4 - Cowl Corner to Fender Seal
- 5 - Windshield (Lower Right Corner)
- 6 - Fender (Rear Corner/Windshield View)

9. Remove and replace the driver side hood hinge pivot bolt (Fig. 3).

NOTE: The front fender does not need to be removed in order to replace the hood hinge pivot bolt which can be accessed through the hood hinge pivot bolt access area (2) shown in (Fig. 3).

NOTE: Torque the new hood hinge pivot bolt to 13ft/lbs(17nm).
