NUMBER: 23-031-12

Front Left Seat Squeak

2012 (JK) Wrangler

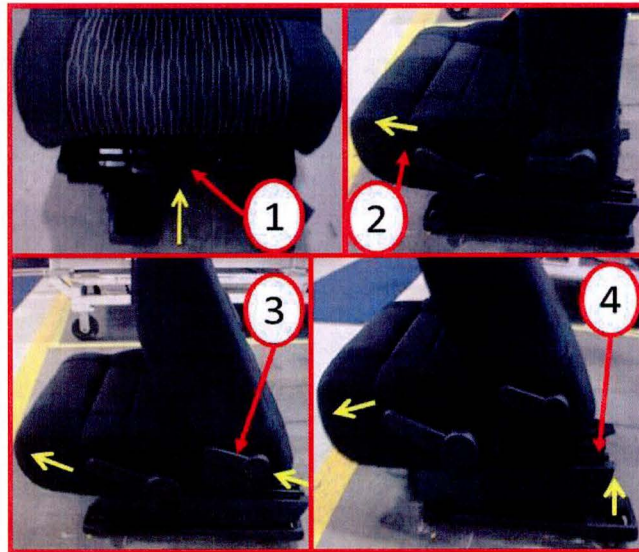
Fig. 1 Seat Adjustment

The customer may experience a seat squeak while driving the vehicle or moving in the seat

1. Position the driver seat in the full forward position (Fig. 1).
2. Pull the easy entry handle and position the seat back in the full forward position (Fig. 1).

NOTE: When the seat back is in the full forward position this will activate the tip slide mechanism which will rock the seat assembly toward the instrument panel at the base of the seat in order to gain access to the area of repair.

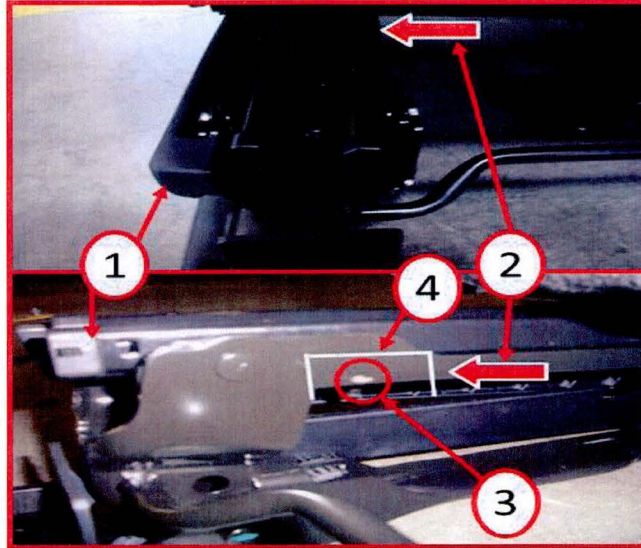
Fig. 2 Apply Nye Grease

This bulletin involves applying Nye grease to the contact points between the inner and outer seat brackets located near the back of the outboard bracket on the left front seat at the tip slide mechanism.

-
3. Apply Nye grease to the inboard side of the outboard rail on the tip slide mechanism in the specified area shown in (Fig. 2).
