**NUMBER:** 23-032-12

Front Windshield Appears Chipped At The Bottom Edge

2013 (JK) Wrangler

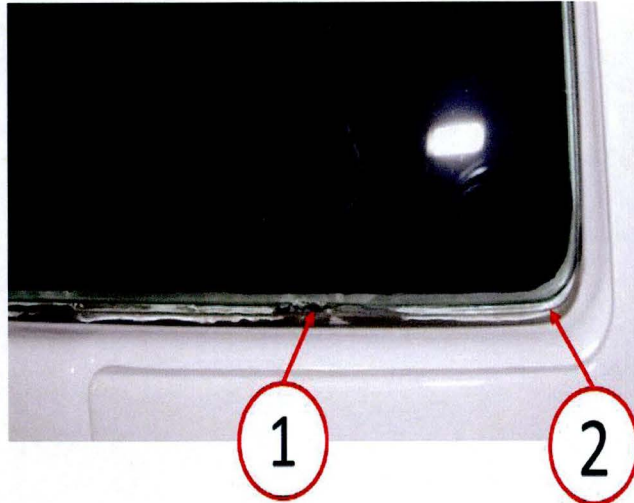
**Fig. 1 Front Windshield**

Windshield appears chipped at the bottom edge.

- 1 - Windshield Chipping Appearance
- 2 - Lower Left Corner Of Front Windshield

**NOTE: The windshield is not chipped and only appears to be, due to vinyl sheet being too long between the two pieces of glass. This can occur anywhere along the bottom edge on the front windshield.**

- 2. Remove and replace the front windshield. Refer to the detailed service procedures available in: DealerConnect> TechCONNECT under: Service Info> 23-Body> Stationary Glass> Removal/Installation.
