NUMBER: 23-033-12

Rear Fascia Underflush At Quarter

2011 - 2012 (MK)

Jeep Compass

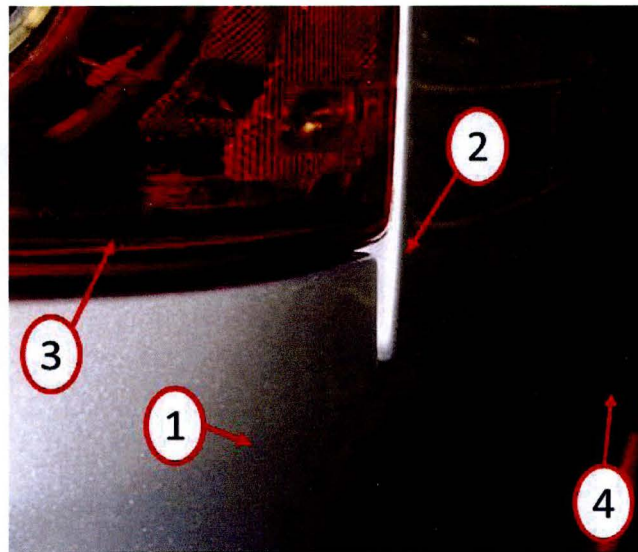
Fig. 1 Rear Fascia Underflush At Quarter

The customer may notice the rear fascia becomes underflush to the rear quarter (Fig. 1).

This bulletin involves replacing the two plastic outer push clip fascia retainers in the lift gate area with a rivet nut and threaded fastener.
