Technical Service Bulletin

01 MIL on (DTC P0491 and P0492), stored at the same time

26 12 15 2026528/7 November 5, 2012. Supersedes Technical Service Bulletin Group 26 number 12-10 dated March 30, 2012 for reasons listed below.

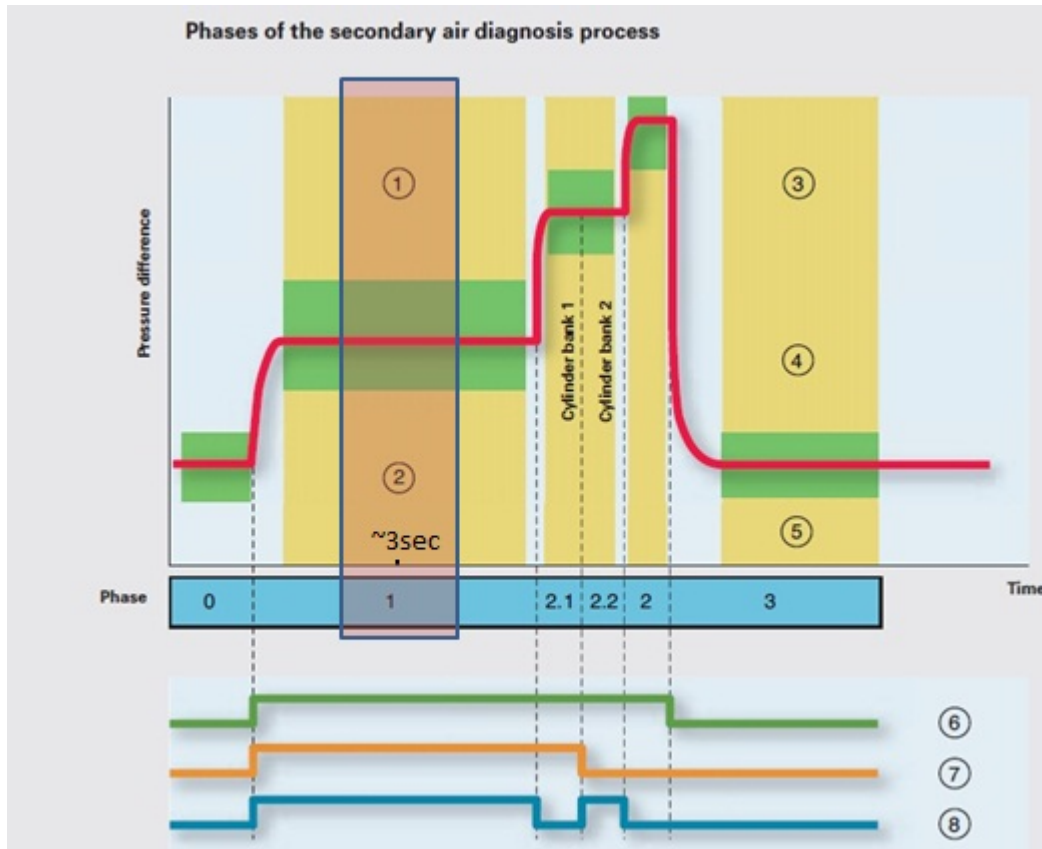
Figure 1. Pressure test graph

PRS_SA_DIF (note down value at 3sec of test - phase 1 of test, see *Figure 1. Pressure test graph*)
