Reference SSM59597

Models XJ / X351 XF / X250

Title 12MY GEN2.1 Audio Amplifier Quiescent drain

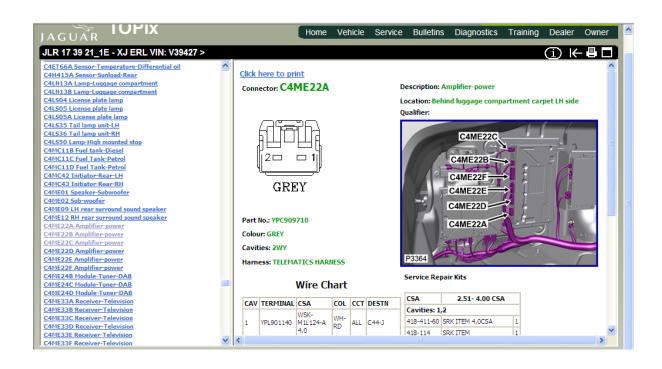
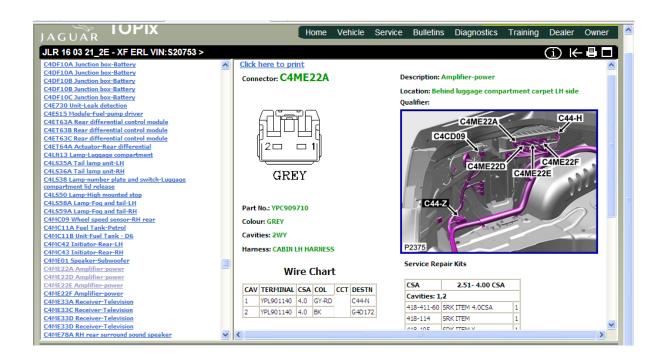
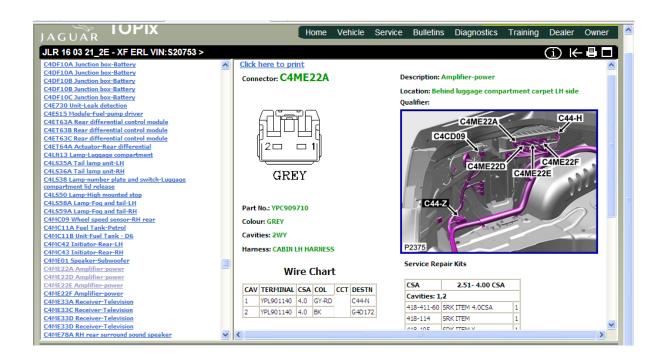
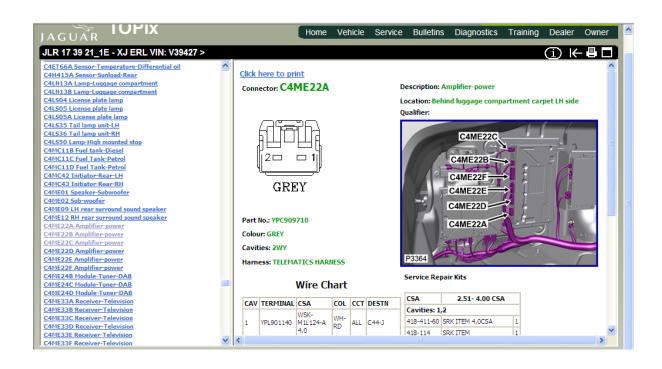
Connector locations from TOPIx attached

Upon diagnosis the battery voltage is low and a quiescent battery drain is observed. The drain may be as a result of a capacitor fault within the Audio Amplifier Module on GEN2.1Trim level 2/ High Line/ Premium audio systems only. Low line audio systems that have an internal amplifier in the head unit are not affected.

A guiescent drain can be attributed to one or more of any of the vehicle electrical/electronic systems, however if the vehicle is within the VIN range below it is advisable before Content continuing with further diagnosis to disconnect the electrical connectors C4ME22A, C4ME22B, C4ME22C, C4ME22D, C4ME22E and C4ME22F (please view

attachment) at the Audio Amplifier Module in the right hand rear load space area to see if the guiescent drain is no longer present, if so replace the Audio Amplifier Module (with reference to TOPIx 415-01 Audio Unit) and recheck the vehicle, if the quiescent drain is still present then continue with electrical diagnosis using Symptom Driven Diagnostics (SDD) and reference to TOPIx.
