SERVICE BULLETIN

APPLICABILITY: 2011-2012MY Forester Models with FB Engine **NUMBER:** 02-131-12R
SUBJECT: Oil Seepage Diagnosis and Repair Procedures **DATE:** 07/18/12
REVISED: 10/02/12

INTRODUCTION

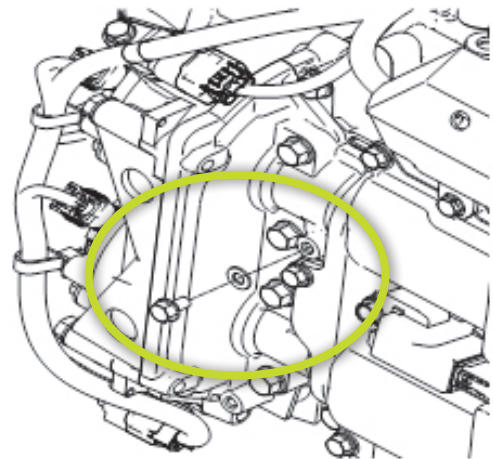
If oil seepage is verified coming from the 6mm threaded hole in the left-hand camshaft cap, install the specified bolt and flat washer.

Bolt: Part# 800206180

Washer: Part# 031106000

Tightening Torque: 6.4 +/- 0.5 Nm
(57 +/- 4 inch-pounds)

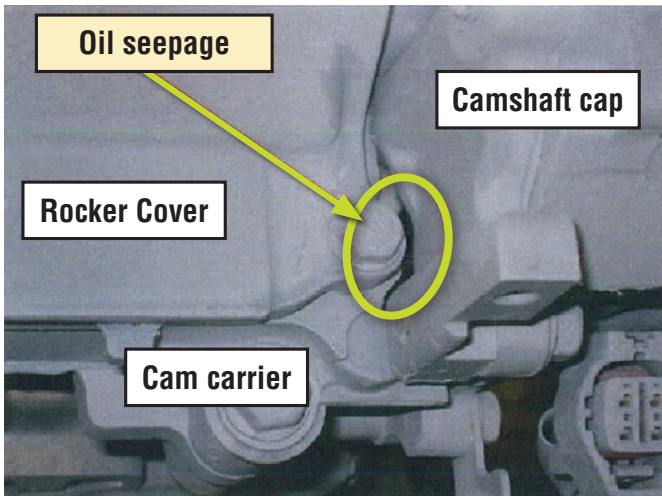
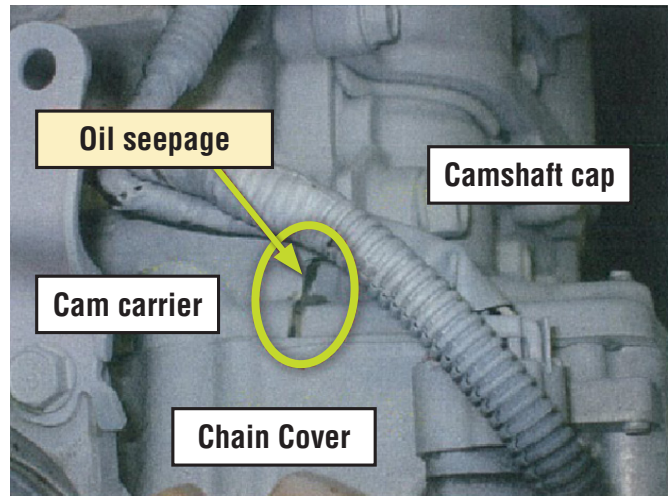
If oil seepage is verified coming from the front camshaft cap or cam carrier as shown in the photos below, remove the cam cap and clean both surfaces thoroughly before applying sealer. **Note:** The 2 o-rings between the camshaft cap and the cam carrier will need to be replaced as they are not re-usable.

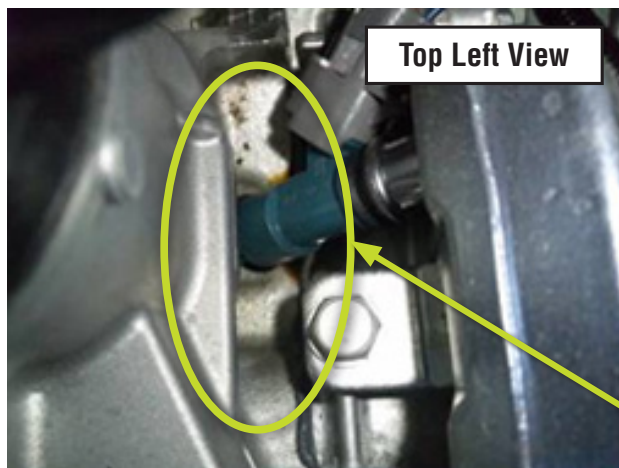
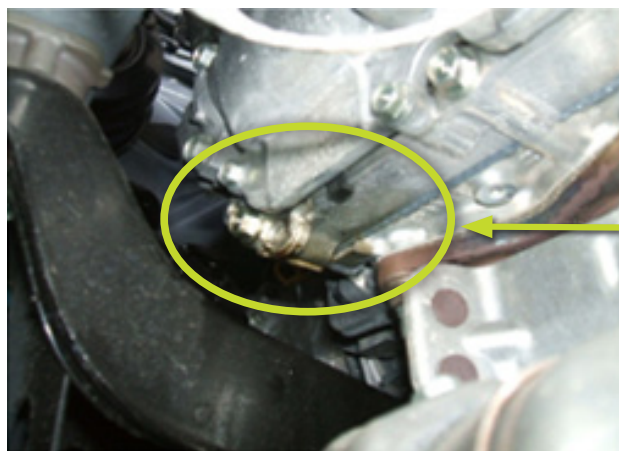
If oil seepage is verified coming from between the cam carrier and the cylinder head as shown in the photos below, remove the cam carrier. Clean the machined sealing surfaces thoroughly and then re-seal using Liquid Gasket ThreeBond 1280B, (Part No. SOA5499100) or equivalent*. As shown in the photos below, the o-rings between the cam carrier and the cylinder head will need to be replaced as they are not re-usable. This would also be a good time to clean the Active Valve Control System (AVCS) filter screens which are contained in the cam carriers. **NOTE:** The filter screens are one-time use and must be replaced if they need to be removed. The replacement filter part# is 14451AA050.

Cam carrier seepage seen from top left and lower right side of engine

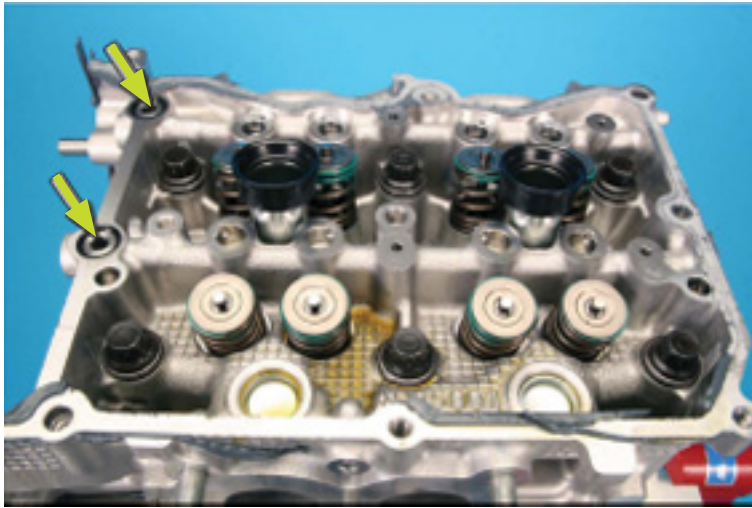
Cam carrier o-rings requiring replacement

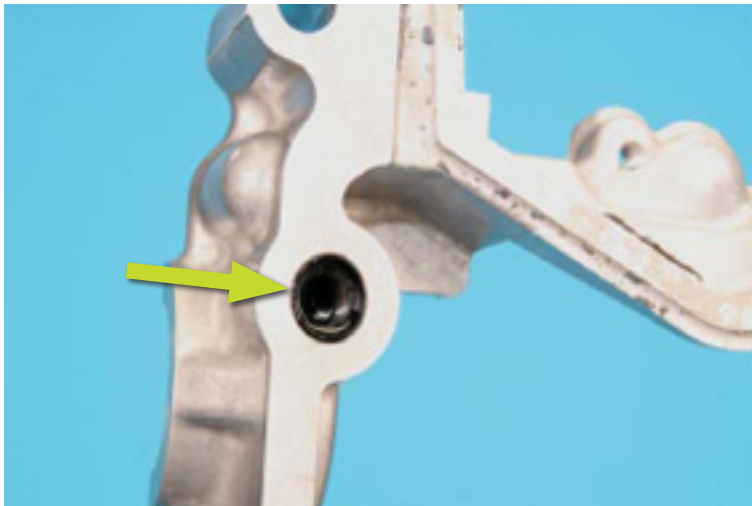
AVCS filter screen in cam carrier

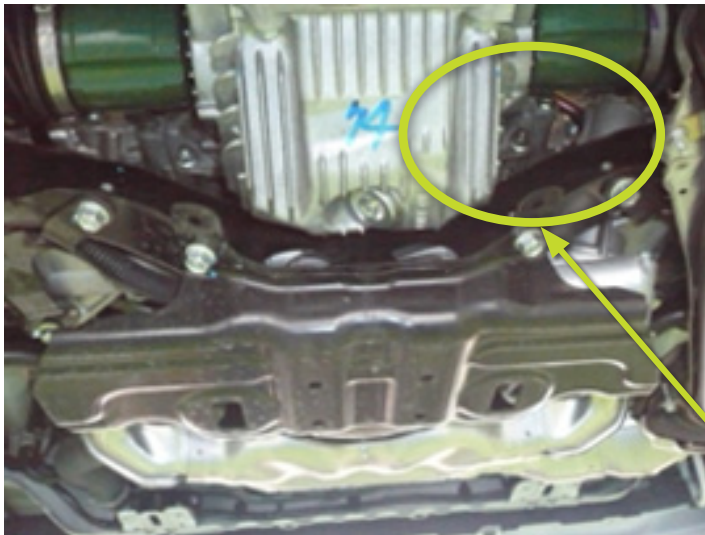
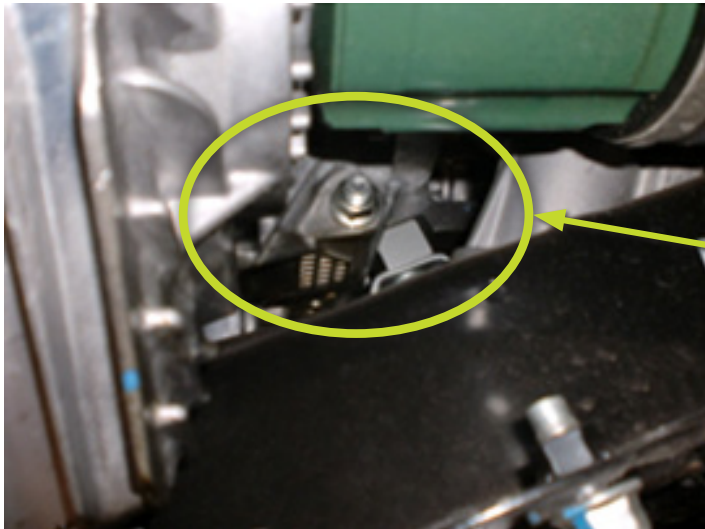
As viewed from the rear, oil seepage from the upper pan to engine block sealing area may be present in these areas.

If you find engine oil seepage between the cylinder block and upper oil pan, remove the upper oil pan, clean the machined sealing surfaces thoroughly and then re-seal using Liquid Gasket ThreeBond 1280B, (Part No. SOA5499100) or equivalent*. **Note:** The o-rings between the upper oil pan and the cylinder block along with those between the upper and lower oil pan will need to be replaced as they are not re-usable.

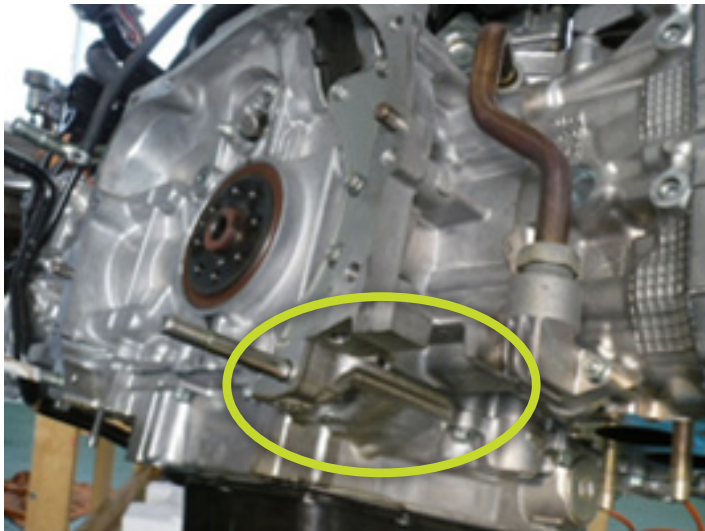
Photo shows seepage from upper oil pan to engine block sealing surfaces.

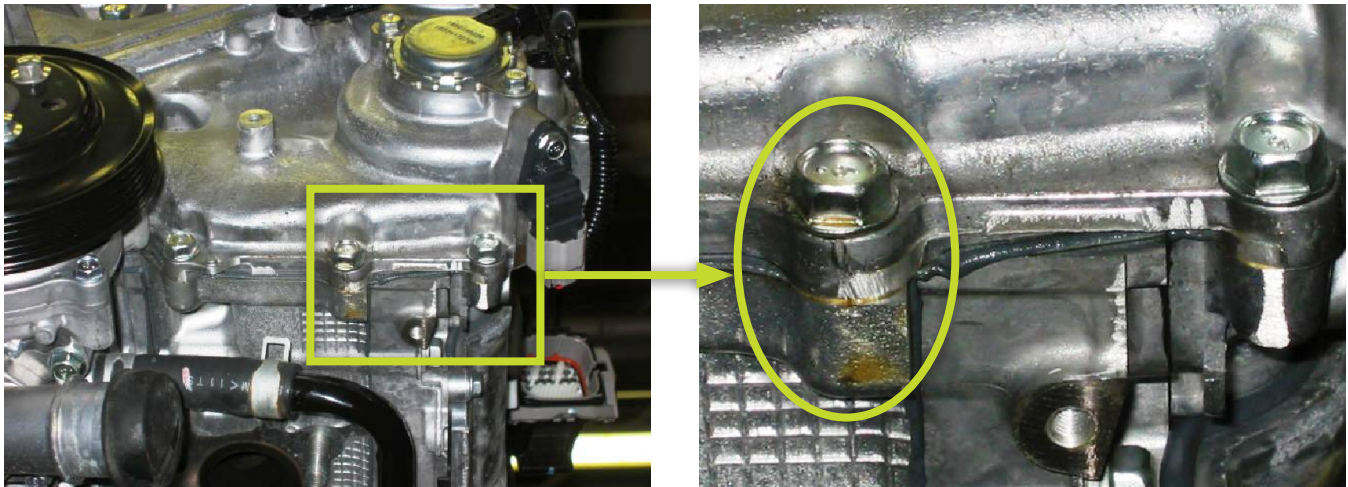
Front Timing Chain Cover resealing procedures:

Note: Only reseal the front chain cover AFTER confirming there is no oil seepage coming from the cam retainer cap (area 1) as previously described.

1. If there are no oil droplets found on the engine under-cover or the lower radiator hose, thoroughly clean the chain cover sealing area along with the surrounding cylinder head and crankcase areas. Re-check for oil seepage again at the next service interval.
2. If the front chain cover is leaking and needs to be resealed, follow the repair procedure in the applicable Service Manual. Thoroughly clean and inspect the sealing surfaces then re-seal using Liquid Gasket ThreeBond 1280B, (Part No. SOA5499100) or equivalent*.
