**QUALITY DRIVEN® SERVICE****SERVICE BULLETIN****APPLICABILITY:** 2011-**2013**MY Legacy and Outback**SUBJECT:** Sunroof Binds**NUMBER:** 12-124-10R**DATE:** 10/18/10**REVISED:** 10/23/12**INTRODUCTION**

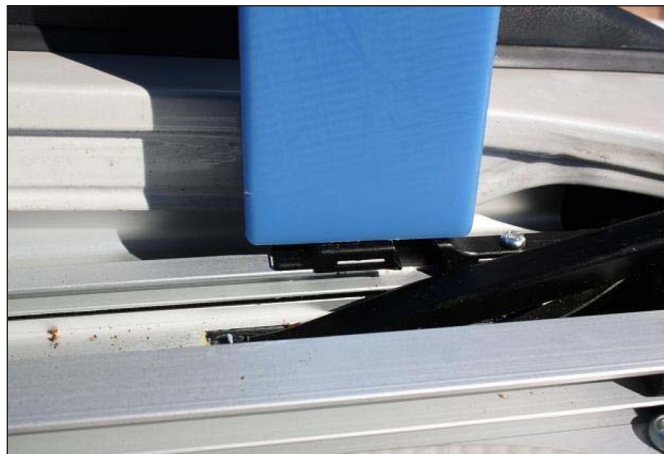
If you encounter a customer complaint when opening the sunroof (the glass opens about one inch then stops, makes a squeak type sound and/or opens halfway then binds), the wedge cap may be out of alignment. If the wedge cap is too high on one side, it will cause the sunroof glass to bind, which will cock the glass. Refer to the service procedure to remedy the condition.

- 1) Open the sunroof glass and determine which side needs adjustment. **Note:** In just about all cases, the left side requires adjustment.
- 2) Place a solid block as shown; make sure it is square and flush on top of the wedge cap.
