SERVICE BULLETIN

APPLICABILITY: 2008-2013MY Impreza WRX and STI Models **NUMBER:** 12-141-12
SUBJECT: Front Bumper Fascia Excess Gap Repair Procedures **DATE:** 10/25/12

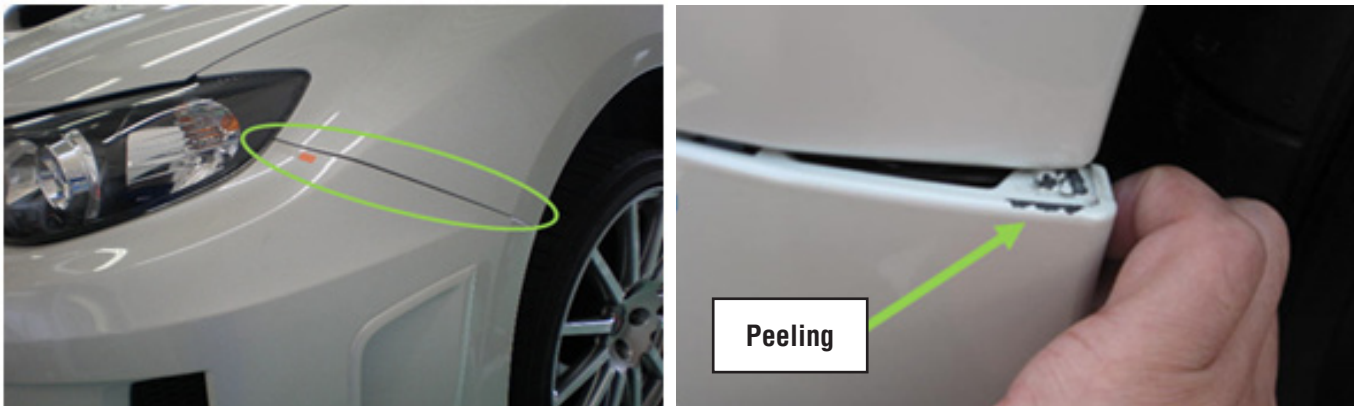
This bulletin provides a procedure to repair a gap which may develop between the front bumper fascia and the fender. Also included is a repair procedure to prevent recurrence of peeling paint film at the rear corner of the front bumper fascia where it may come in contact with the bottom of the fender.

If a gap is verified between the bumper fascia and the fender as shown in the left hand photo on page 1, it is likely the fascia has come loose from the side mounting bracket(s).
