### SERVICE BULLETIN

APPLICABILITY: 2012 and 2013MY Impreza

**SUBJECT:** Squeaking Sound from Front Seat Backrest

## NUMBER: 12-142-12

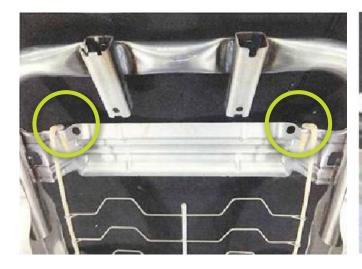
This Bulletin provides a repair procedure to address a customer concern of a squeaking-type sound coming from the driver or passenger front seat back. The flat mat main support rods are covered in paper to prevent metal-to-metal contact with the backrest frame. However, if an edge on the backrest frame damages the paper, metal-to-metal contact will result, creating the squeak. Bushings will need to be installed to prevent the condition. This procedure eliminates the need to replace the backrest frame.

The photo on the left shows the two locations where the sound originates, looking down from the top front of the backrest frame. The photo on the right shows one of the flat mat's main support rods (wrapped in paper) in position after the bushing installation procedure has been completed.

- Record customer's preset radio stations (and Navigation system favorites if applicable).
- Disconnect the negative (-) battery cable and wait at least 60 seconds before proceeding further.
- Remove the affected seat from the vehicle (refer to the applicable Service Manual).
- Remove the seat trim cover and cushion material as an assembly from the backrest.
- Remove the flat mat support rods from the top of the backrest frame, one side at a time.
- Install the bushings into the backrest frame as shown in the photos below. **NOTE:** putting the bushing in hot water (104° to 122° f) for a few minutes will ease their installation.

- After the bushings return to room temperature, confirm they are tight in the backrest frame and cannot be pushed out without using excess force (more than 5 to 6 lbs.).
- Reassemble the seat assembly.
- After reinstalling the seat, confirm the sound has been eliminated.
- Reconnect the negative (-) battery cable.
- Reset customer's preset radio stations (and Navigation system favorites if applicable).
