SERVICE BULLETIN

APPLICABILITY: 2013MY BRZ

NUMBER: 12-140-12

SUBJECT: “Clack” or “Popping” Sound from Trunk and /or Rear Shelf Area

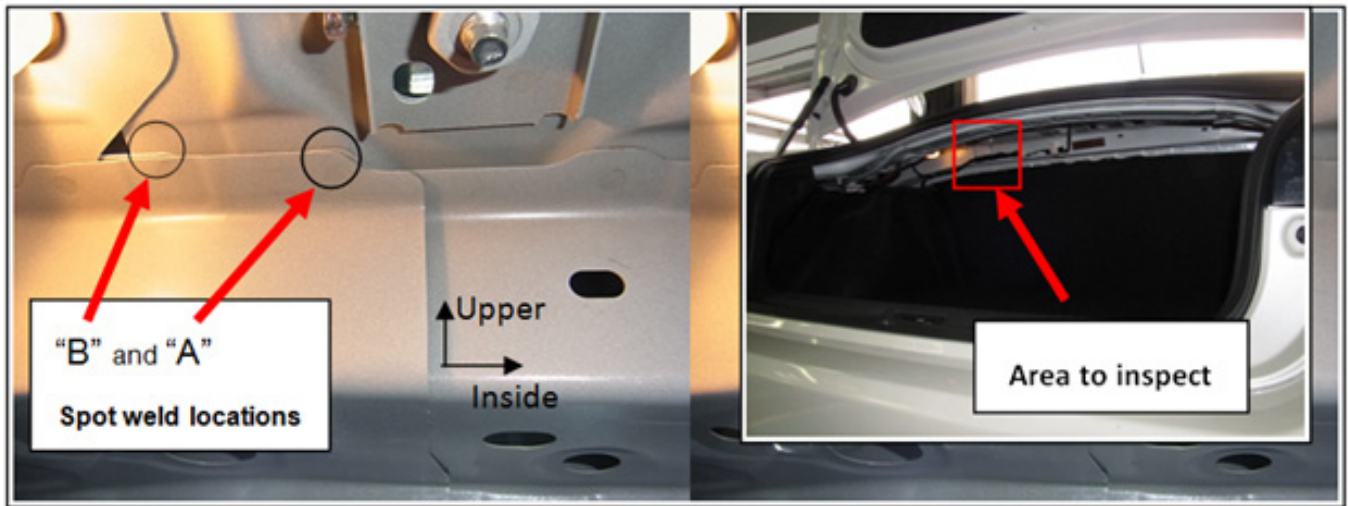
The photo below shows the location of the area of the spot weld to inspect on the Driver's (left) side.

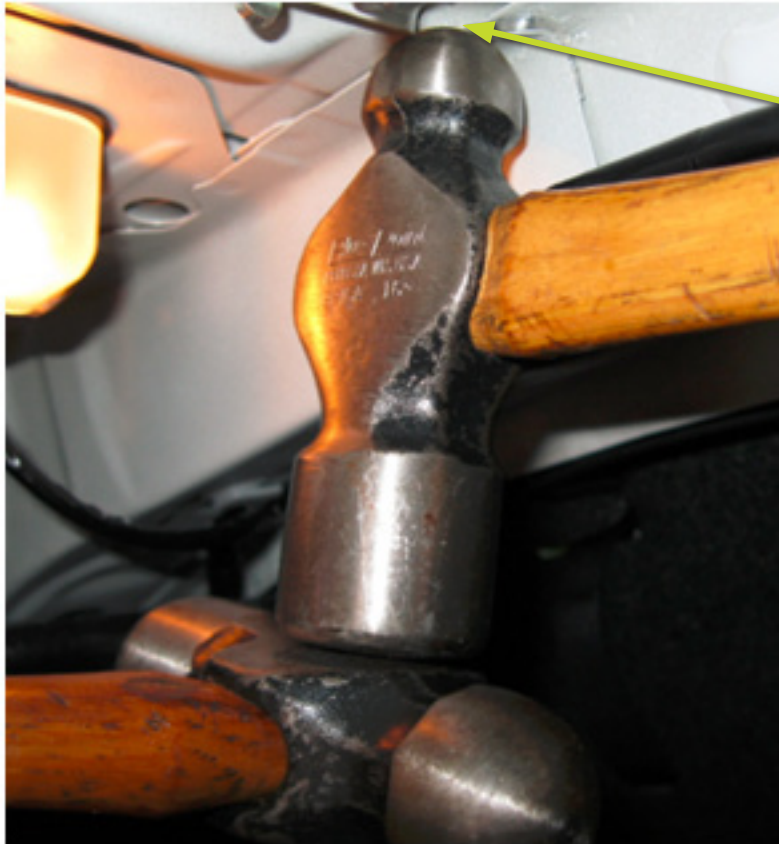
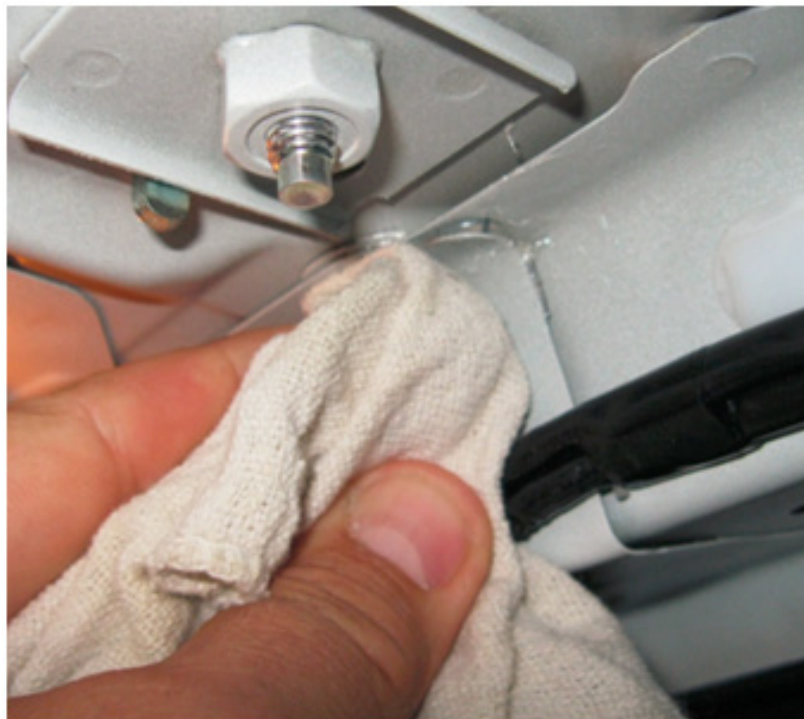
Photo shows positioning of tools used to close the gap between the plates.

Be careful not to use excessive force.

Once the gap has been reduced, wipe off any excess grease then be sure to touch up any damage to the finish as necessary. Once the Case #1 procedure has been completed, road test the car to confirm the sound no longer exists. If the sound persists, the following Case #2 procedure will be required.
