Technical Service Bulletin

87 Air conditioning inoperative

87 12 37 2020124/8 November 16, 2012. Supersedes Technical Service Bulletin Group 87 number 12-32 dated September 5, 2012 for reasons listed below.

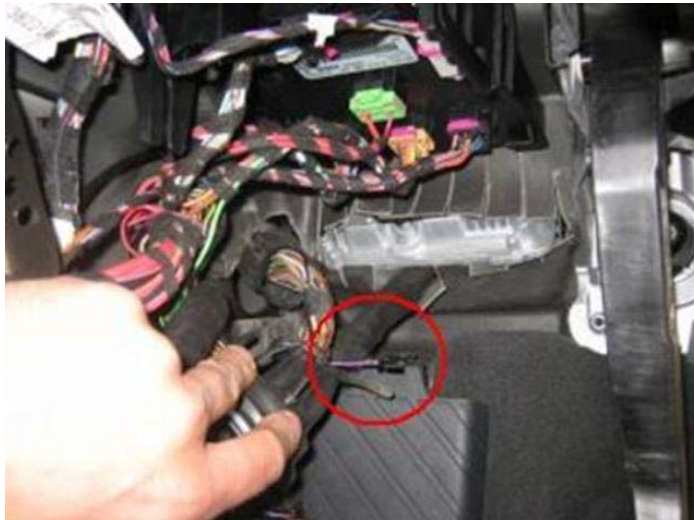
There are two known sections in the wiring harness that can be affected, but the potentially affected areas are not limited to these two known sections. One of the known sections is in the driver's footwell area where the wire harness enters the interior of the car from the engine bay (Figure 1).

Figure 1. Wire harness in driver footwell area.

6. If a cut wire is found, install an overlay wire for the LIN bus signal. Do *not* attempt to repair the existing wire harness.

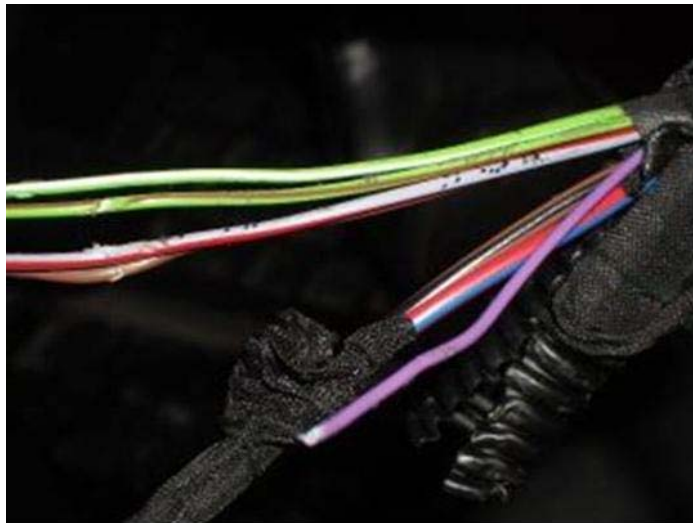
The second known section is in the wire harness located under the driver's side headlight (Figure 2).

Figure 2. Wire harness under driver's side headlight.

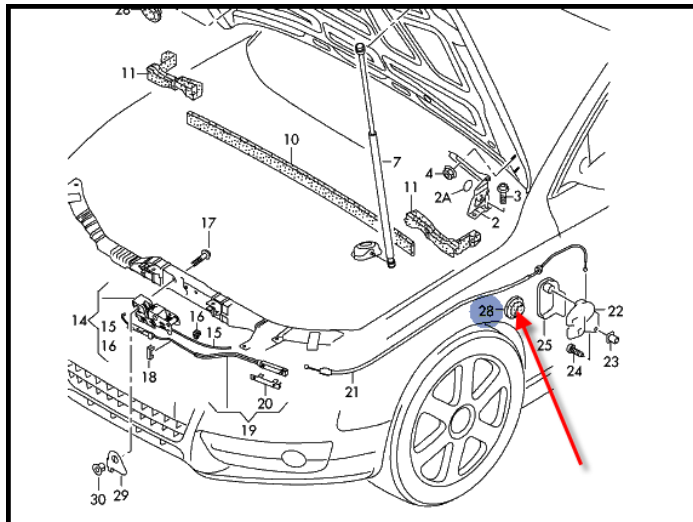
Figure 3. Grommet in driver's side fender/lower A-pillar area used for pass-through for new overlay wire.

- a. Route the new LIN bus wire from the power system control unit J519 to the sender for refrigerant pressure/temperature G395 so that it enters the interior of the vehicle through the driver's side fender/lower A-pillar area through the grommet indicated in Figures 3 and 5.

Tip: Do *not* route the wire through the same opening used by the existing wire harness.

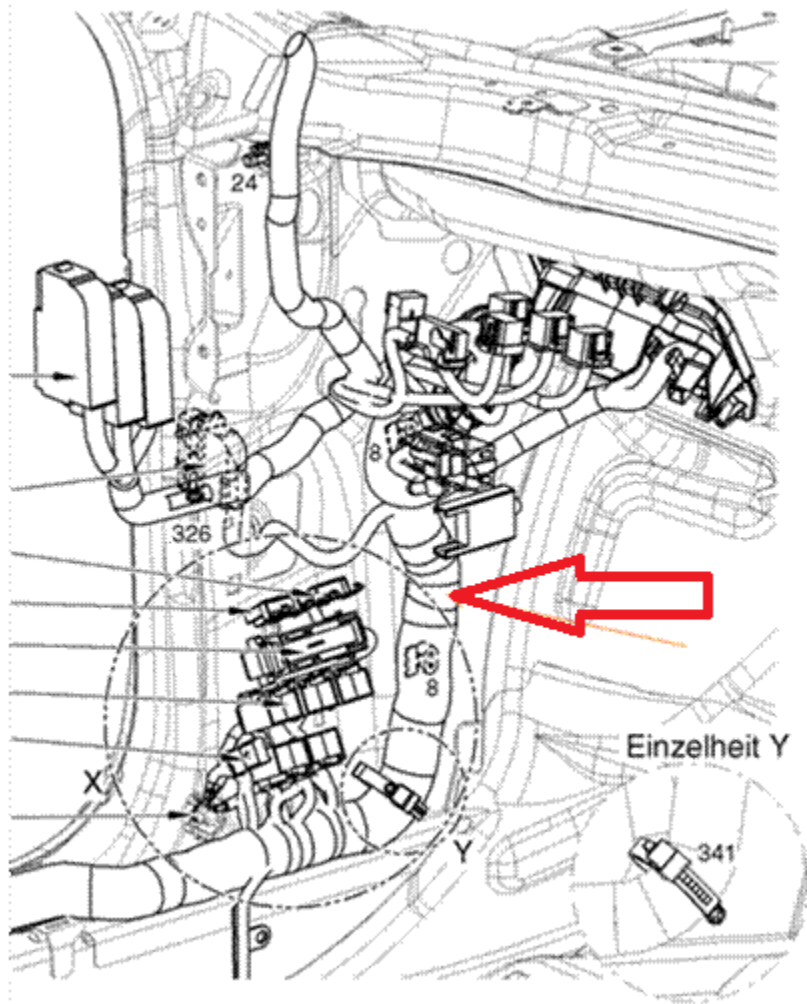
Figure 4. Cable routing with charisma switch option.

On vehicles with a charisma switch (ride selection switch located on the instrument panel) route the new cable of the sender for refrigerant pressure/temperature G395 to junction B549 as indicated by the red arrow in Figure 4.

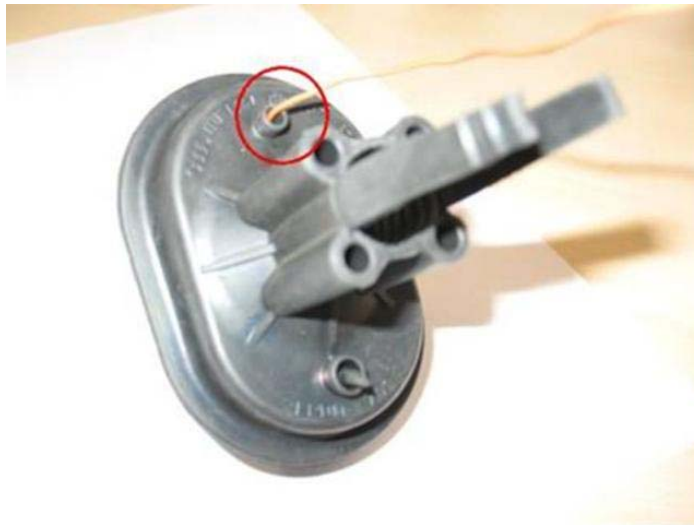
Figure 5. Seal off access hole in grommet with Butyl sealant.

- b. Seal off the opening around the wire with Butyl sealant to prevent water intrusion.
