Technical Service Bulletin

90 Rattle sound from Heads Up Display

90 12 37 2029843/3 November 12, 2012. Supersedes Technical Service Bulletin Group 90 number 12-36 dated October 4, 2012 for reasons listed below.

Model(s)	Year	VIN Range	Vehicle-Specific Equipment
A6/A7	2012	000001-017640	All

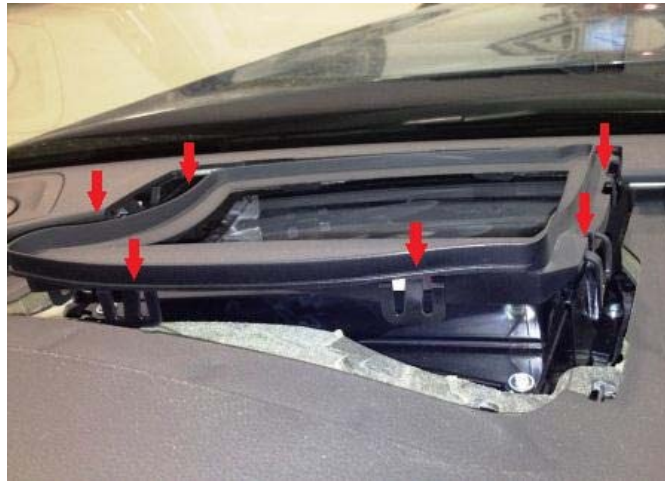
Figure 1. Six latches are shown with red arrows.

2. Remove the outer frame from the Head Up Display unit. To do this, disengage the 6 latches which secure it to the main body of the Head Up Display (Figure 1). Use a small offset pick tool to carefully pry the latches open, while at the same time carefully applying pressure to lift the frame, to prevent the latches from re-engaging (Figure 2).

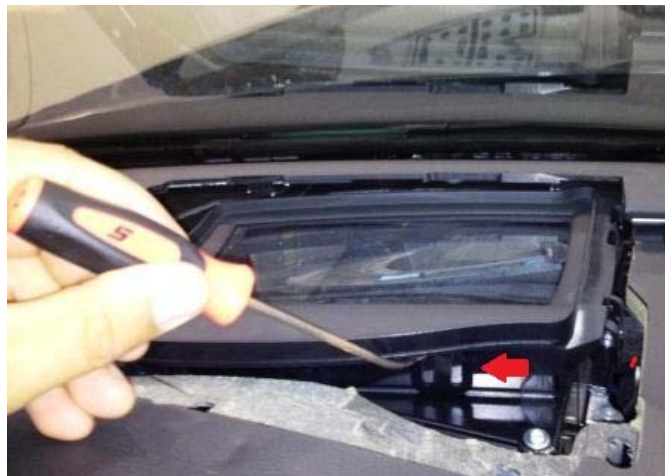
Figure 2. Carefully use a small angled pick tool to delicately disengage the six latches.

Use a high level of caution during steps 2 and 3 not to break the retaining clips when disengaging and when pulling the frame out. The clips are fragile, and the frame is not available as a service part. If damaged, the complete Head Up Display must be replaced.

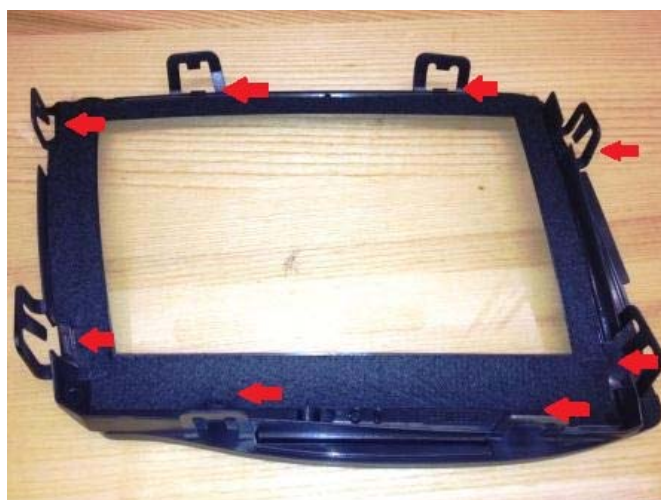
Figure 3. Eight positive standoffs that must not be covered by the felt tape are shown with red arrows.

4. Trim and apply adhesive felt tape to the underside of the frame. The eight standoffs molded into the surface and marked with red arrows MUST NOT be covered; otherwise, the retaining clips will not re-engage (Figure 3).
