Technical Service Bulletin

57 - Remotes sporadically not recognized

91 12 69 2031664/1 November 12, 2012.

Model(s)	Year	VIN Range	Vehicle-Specific Equipment
A7	2012	All	Not Applicable

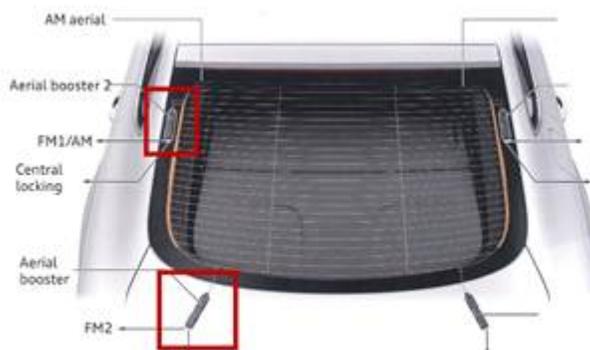
A portion of A7 production was built with the incorrect antenna amplifiers in the vehicle, which causes sporadic operation of the keyless remote, especially when paired with Audi Advanced Key.

Figure 1. Antenna locations.

1. Remove the rear hatch covers to access both antenna amplifiers on the driver's side of the liftgate (Figure 1.).

2. Verify both part numbers are correct for the vehicle:
 - Aerial Booster 2 (upper): **4G8 035 225**
 - Aerial Booster (lower): **4G8 035 225 A**
3. If either part number is incorrect for the vehicle, replace the incorrect part.
