# Technical Service Bulletin

## 94 Moisture accumulation in headlamps

94 12 98 2028277/4 November 21, 2012. Supersedes Technical Service Bulletin Group 94 number 12-91 dated October 24, 2012 for reasons listed below.

Model(s)	Year	VIN Range	Vehicle-Specific Equipment
Q7	2010 - 2014	All	Not Applicable

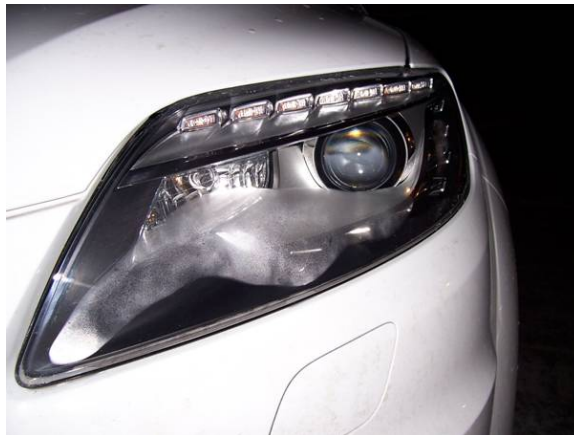
- Considerable moisture present in headlamp.
- The moisture disappears only after extended drives (greater than 10 minutes).

- No external damage to headlamp which could introduce moisture.

*Figure 1. Moisture in headlamp.*

Humid air settles on the inside of the glass, causing moisture to appear on the inside of the headlamp lens. Because of the headlamp circulation system, outside air is allowed to flow through the headlamps. The open, water-protected ventilation system (needed for pressure compensation) creates different “ climate zones” inside the headlamp, where the lens is either warmed up by the light or cooled down by passing air.

When high air humidity and temperature differences exist between the inside of the headlamps and the outside, condensation can form on the inside of the lens, especially in cold and wet weather. The moisture in the headlamps can be compared with condensation on the windshield, which is cleared by the “defroster vent”. This moisture buildup can happen for example: after a car wash, after steam cleaning of the engine or the front end, or after overnight temperature changes.

1. Remove the headlamps and dry the inside using compressed air or hot air blower.

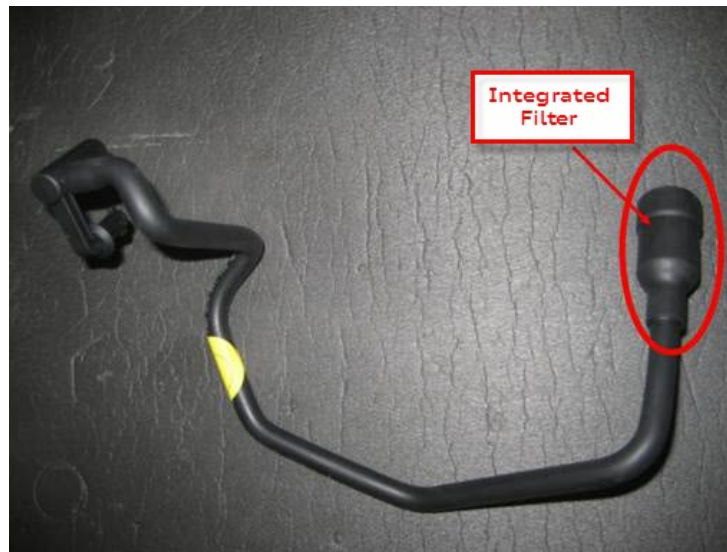
*Figure 2. Updated ventilation hose with integrated filter.*

2. If vehicle's build is prior to VIN # \*CD004736, replace the headlamp ventilation hose for each headlamp with the new part number to help reduce any further humidity ingress into the headlamps (see Part information table below). Otherwise, move to step 3.

The updated ventilation hose can be recognized by the integrated filter (Figure 2).

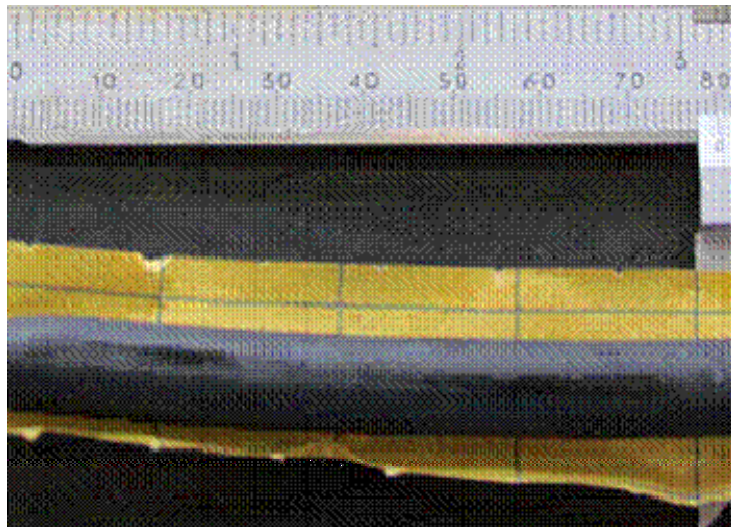
*Figure 3. Butyl cord sealant, 10mm diameter.*

3. Cut two sections of butyl cord sealant, 8cm long each (Figure 3).

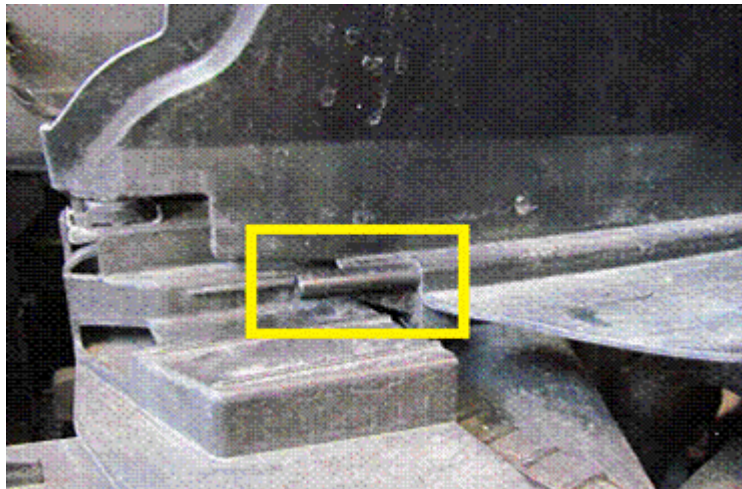
*Figure 4. Headlamp ventilation guide tube.*

4. Each headlight ventilation guide tube must be sealed to protect against further moisture ingress (Figure 4).

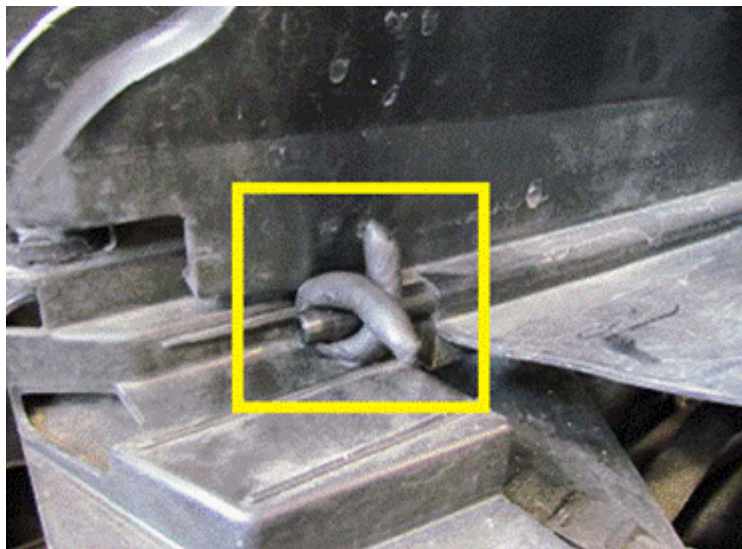
*Figure 5. Initial butyl cord shown on guide tube.*

5. Wrap butyl cord sealant around the left and right ventilation tubes, taking care not to block the air passage tube (Figure 5).

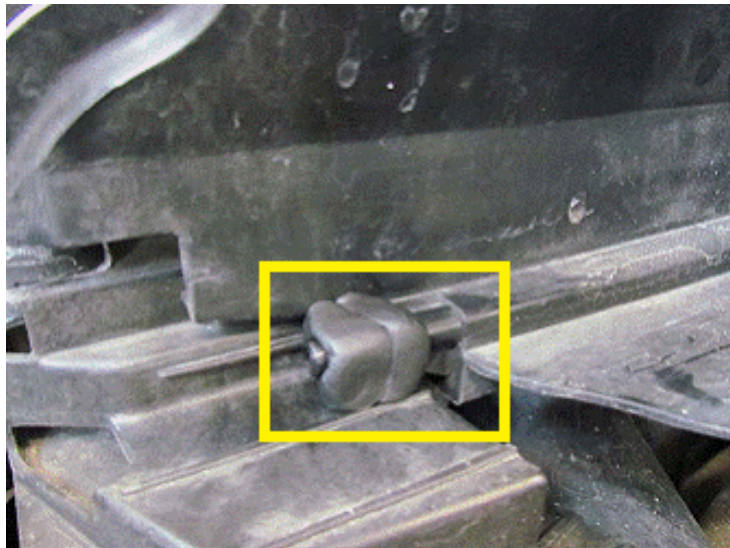
*Figure 6. Butyl cord kneaded in place.*

6. Knead the butyl cord sealant in place. The butyl sealant must be excessive enough so that the headlamp housing squeezes it and creates a robust seal at the housing (Figure 6).

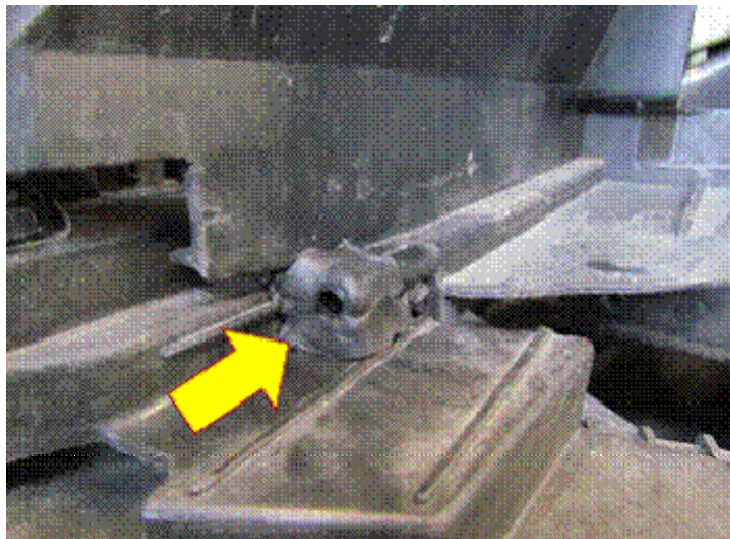
*Figure 7. View of direction of headlamp engagement, with appropriate butyl cord application.*

7. Leave an uncovered section of the air tube so that there is no chance the sealant will clog the air passage tube (Figure 7).
