Technical Service Bulletin

UPDATE 23F1 - SVM update and Missing Emblems (FED_EMS)

November 16, 2012. Supersedes Technical Service Bulletin Group 23 number 10-05 dated February 26, 2010 for reasons listed below.

Model(s)	Year	VIN Range	Vehicle-Specific Equipment
Audi Q7	2010	000492 – [REDACTED]	Not Applicable

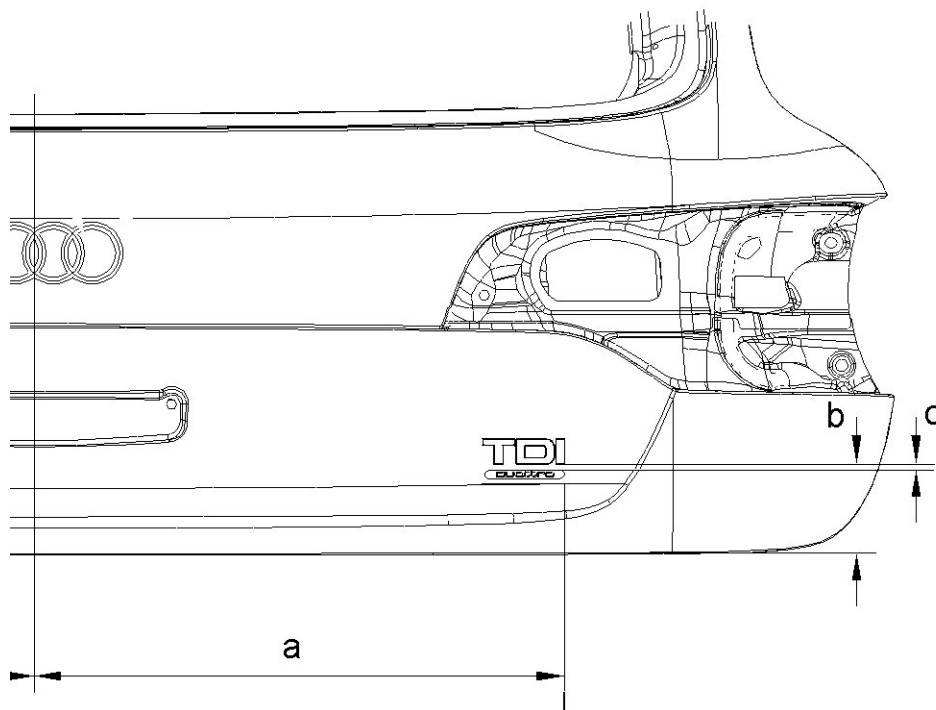
Figure 2.

- A. The right edge of “TDI” emblem relative to the center of vehicle: **531.0 mm**.
- B. The bottom edge of the “TDI” emblem relative to the bottom edge of lift gate: **82.0 mm**.
- C. The spacing between the “TDI” emblem and the “quattro” emblem: **4.0 mm**.

2. Use the dimensions in Figure 2 to align the emblems.
