Technical Service Bulletin

90 Topview/Cornerview camera does not work, PR No. KA4 or KA6 - A6, A7, A8

90 12 33 2030904/1 September 21, 2012.

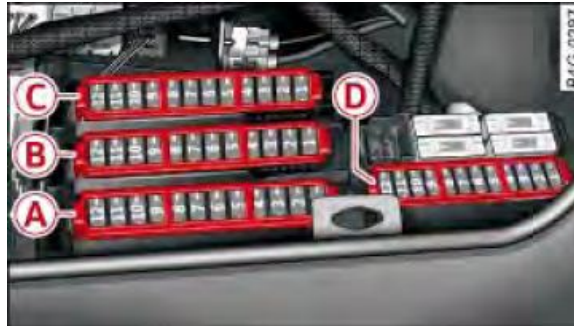
Figure 1. Fuse panel for A6/A7 vehicles.

2. If a draw is detected in step 4 of TSB 2029010, measure the voltage drop across the fuse for J928 as instructed. The fuse for J928 is located:

- **A6/A7:** Right trunk side panel, fuse carrier "C" (brown), position 10 (Figure 1).
- **A8:** Trunk, fuse carrier "F" (brown), position 12 (Figure 2).

3. If the calculated draw value is over 50mA, replace J928.
