# Technical Service Bulletin

## 90 Rattle sound from Heads Up Display

90 12 36 2029843/2 October 4, 2012. Supersedes Technical Service Bulletin Group 90 number 12 – 29 dated June 15, 2012 for reasons listed below.

Model(s)	Year	VIN Range	Vehicle-Specific Equipment
A6, A7	2012	000001 – 017640	All

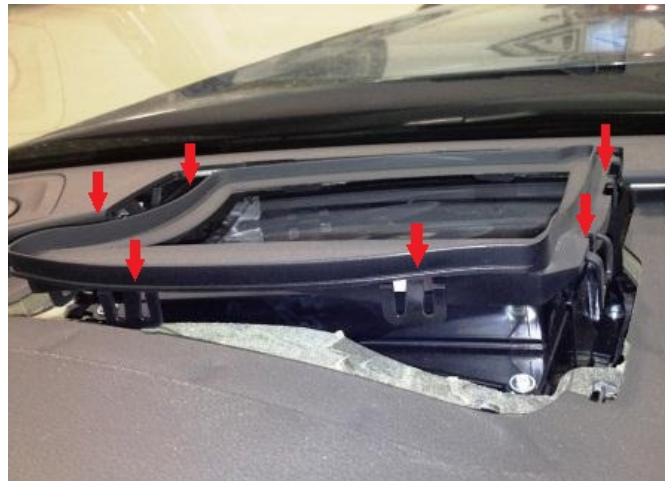
**Figure 1.** Six latches are shown with red arrows.

2. Remove the outer frame from the Heads up Display unit. To do this, disengage the 6 latches which secure it to the main body of the Heads up Display (Figure 1). Use a small offset pick tool to carefully pry the latches open, while at the same time carefully applying pressure to lift the frame, to prevent the latches from re-engaging (Figure 2).

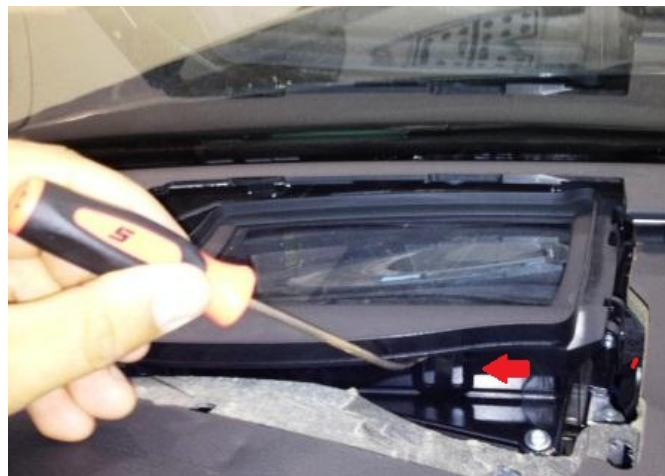
**Figure 2.** Carefully use a small angled pick tool to delicately disengage the six latches.

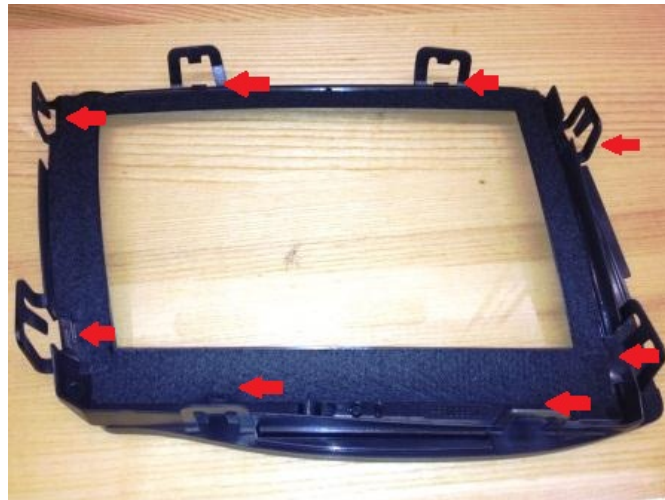
**Figure 3.** Eight positive standoffs that must not be covered by the felt tape are shown with red arrows.

- Trim and apply adhesive felt tape to the underside of the frame. The eight standoffs molded into the surface and marked with red arrows **MUST NOT** be covered; otherwise, the retaining clips will not re-engage (Figure 3).
