# Technical Service Bulletin

## 91 MMI 3G+ Various Technical Issues (K0566 Update)

91 12 59 2030465/2 September 17, 2012. Supersedes Technical Service Bulletin Group 91 number 12 – 56 dated August 17, 2012 for reasons listed below.

Model(s)	Year	VIN Range	Vehicle-Specific Equipment
A6	2012	All	MMI 3G+
A7	2012		
A8	2011 – 2012		
Audi Q7	2012

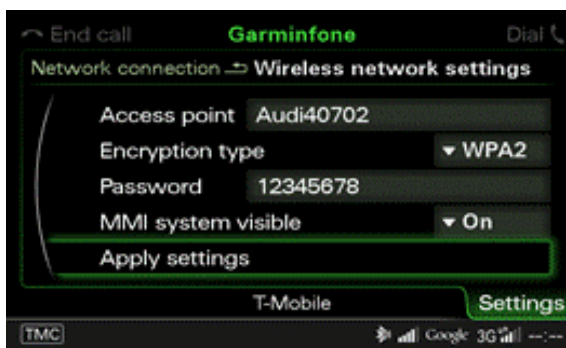
Figure 1. Wireless network settings.

1. As part of the update, wireless settings and paired devices will be deleted. All devices will need to be re-paired after the update, and all wireless settings restored to the customer's settings. To access the Wireless network settings on the MMI (Figure 1), press *TEL >> Settings >> Wireless network connection >> Wireless network settings*. Record all settings so they can be re-entered at the end of the update.

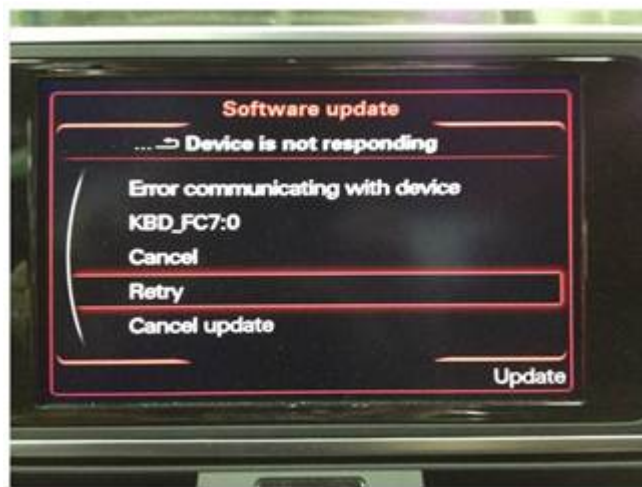
**Figure 2.** A device requiring a 'Cancel' selection.

Some earlier model year 2012 vehicles, or vehicles equipped with Bose® sound systems may experience certain modules that will not update properly during Step 16 of TSB 2028141. If this should occur, either choose 'Cancel' (Figure 2), or 'Skip device' (Figure 3), depending on the type of error. Do *not* choose 'Cancel update', as this may cause the software update to fail entirely. After the update is finished and the summary page is shown, select 'Retry' at the bottom of the list if it is available to attempt to update the modules again. If 'Retry' is greyed out, then the software update was successful, so select 'Continue' to proceed. In some cases 'Retry' may have to be repeated two or three times to get all modules to update successfully.

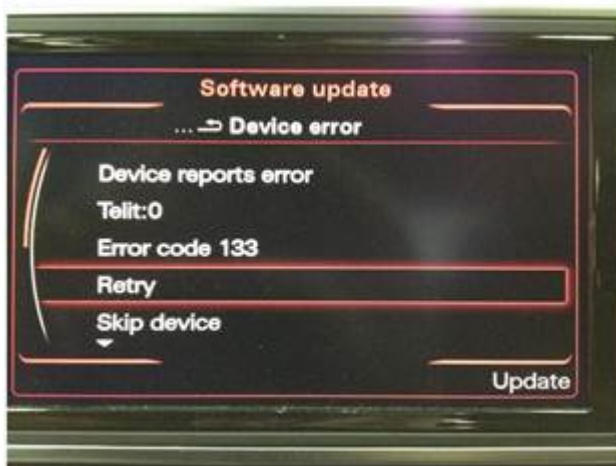
**Figure 3.** A device requiring a 'Skip device' selection.

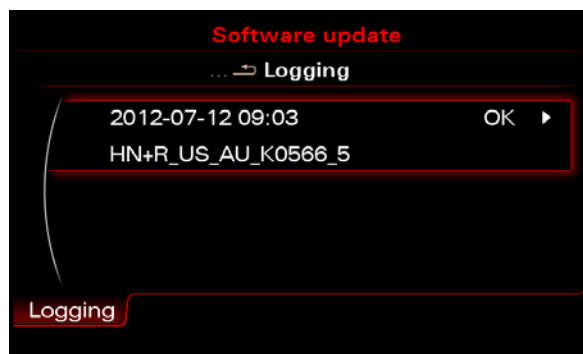
**Figure 4.** Software update log showing a successful software installation.

3. Verify that the software update has been completed successfully by accessing the logging page (Figure 4). To access this screen, proceed to step 8 in TSB 2028141 and press the lower left softkey. A successful update will show the date the update was performed and the software that was installed (HN+R\_US\_AU\_K0566\_X), with 'OK' listed on the right. The 'X' may be one of several different numbers. If K0566\_X does not have any rows with 'OK', the update must be retried until it is successful.

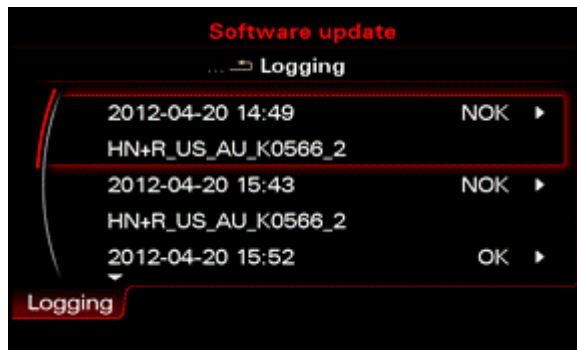
**Figure 5.** Software update log showing 2 failed attempts before a successful installation.

**Tip:** If the update must be performed two or more times due to modules not updating correctly, a screenshot of the software update log is required (Figure 5). This should be kept on-hand for warranty auditing purposes. To take a screenshot, insert an SD Card into slot 1 and press and hold the left and right arrow keys at the same time. All 4 softkeys will flash when the screenshot is taken. A screenshot should be taken of each page in the logging display.
