Technical Service Bulletin

91 MMI 3G+ Various Technical Issues (K0566 Update)

91 12 60 2030465/3 September 24, 2012. Supersedes Technical Service Bulletin Group 91 number 12 – 59 dated September 17, 2012 for reasons listed below.

Model(s)	Year	VIN Range	Vehicle-Specific Equipment
A6	2012	All	MMI 3G+
A7	2012		
A8	2011 – 2012		
Audi Q7	2012

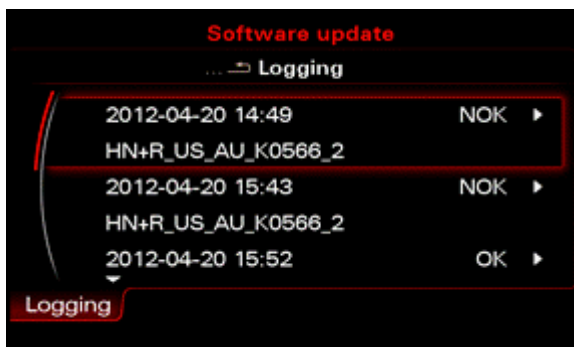
Figure 5. Software update log showing 2 failed attempts before a successful installation.

Tip: If the update must be performed two or more times due to modules not updating correctly, a screenshot of the software update log is required (Figure 5). This should be kept on-hand for warranty auditing purposes. To take a screenshot, insert an SD Card into slot 1 and press and hold the left and right arrow keys at the same time. All 4 softkeys will flash when the screenshot is taken. A screenshot should be taken of each page in the logging display.
