Technical Service Bulletin

94 Headlight moisture accumulation

94 12 89 2030960/1 September 25, 2012.

Model(s)	Year	VIN Range	Vehicle-Specific Equipment
A8	2011	All	Not Applicable
	2012		
	2013	000001 – 008813

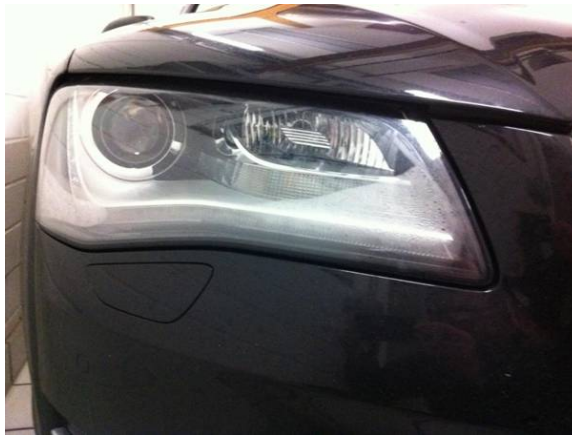
1. Condensation, for example, during in the rain or through a car wash. Also, described as “steaming up” or “fogging”.

Figure 1. Example of a headlight with condensation inside the lens.

1. Remove and dry out the headlight(s) with compressed air (less than 30 PSI).

2. Replace the ventilation hose (Figure 3, 1) and adapter (Figure 3, 3) on both sides and attach it to the mounting (Figure 3, 2). Use the part numbers indicated in the Parts table below.

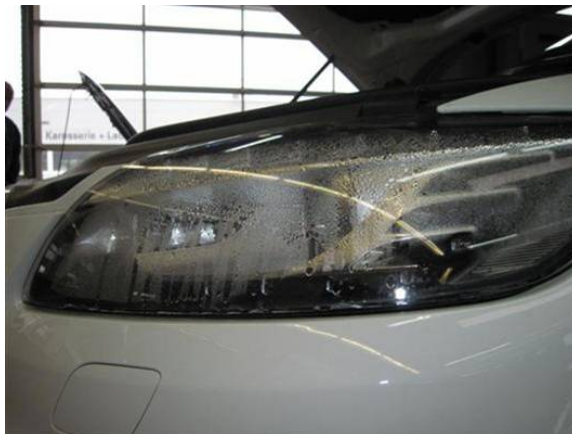
2. Water leaking into the headlight assembly.

Figure 2. Example of a headlight with a leaking condition.

When replacing the headlight, follow the headlight condensation repair instructions above using a new ventilation hose (Figure 3, 1) and adapter (Figure 3, 3) according to the Parts table below. Route the new ventilation hose behind the bumper carrier.

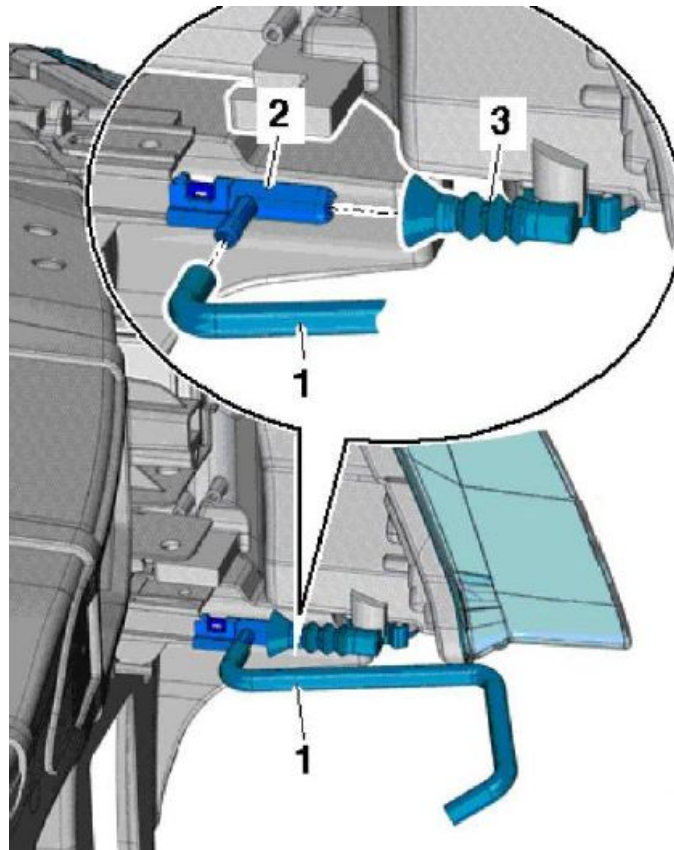
Figure 3. Illustration of the ventilation components.

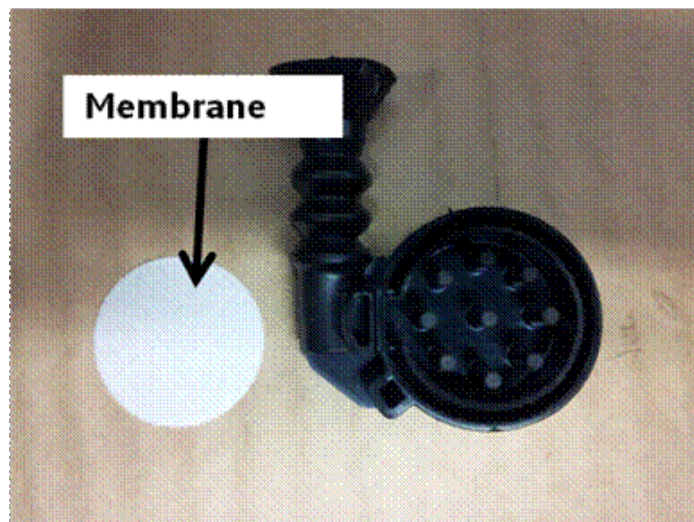
Figure 4. Membrane from original adapter.

3. It is not necessary to use the membrane from the original adapter.

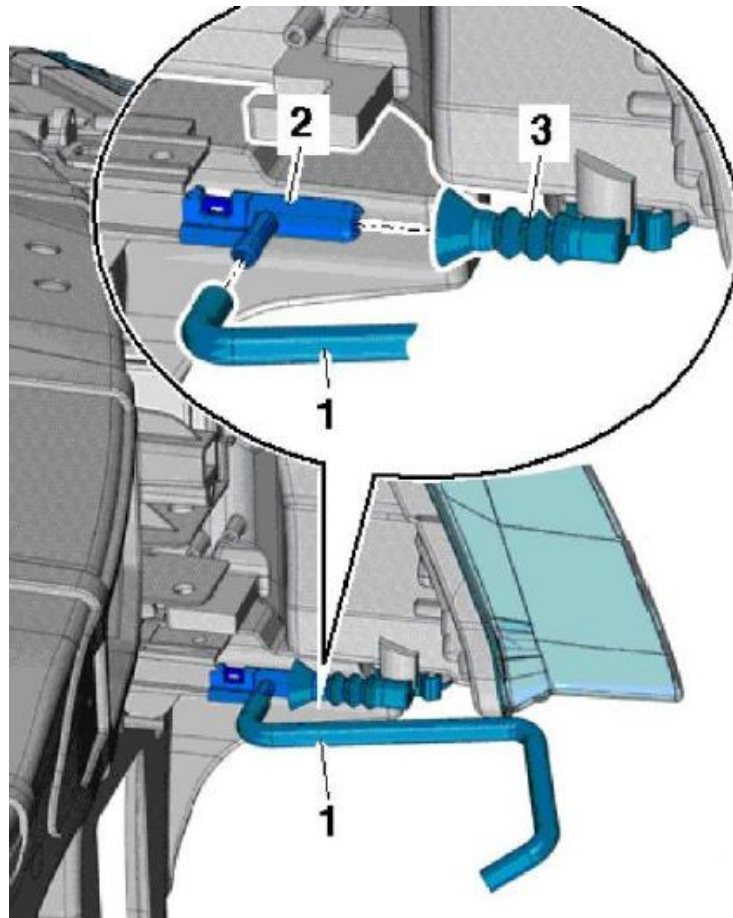
Figure 5. Illustration of the ventilation components.

1. Remove and dry out the headlight(s) with compressed air (less than 30 PSI).
2. Replace the ventilation hose (Figure 5, 1) on both sides and attach it to the mounting (Figure 5, 2). Use the part numbers indicated in the Parts table below.
