Technical Service Bulletin

94 Moisture accumulation in headlamps

94 12 91 2028277/3 October 24, 2012. Supersedes Technical Service Bulletin Group 94 number 12-68 dated March 1, 2012 for reasons listed below.

Model(s)	Year	VIN Range	Vehicle-Specific Equipment
Q7	2010-2011	000001-999999	Not Applicable
	2012	000001-004736

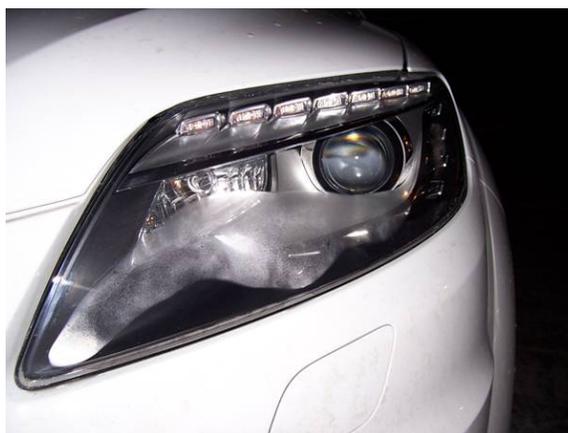
- Considerable moisture present in headlamp.
- The moisture disappears only after extended drives (greater than 10 minutes).

- No external damage to headlamp which could introduce moisture.

Figure 1. Moisture in headlamp.

Humid air settles on the inside of the glass, causing moisture to appear on the inside of the headlamp lens. Because of the headlamp circulation system, outside air is allowed to flow through the headlamps. The open, water-protected ventilation system (needed for pressure compensation) creates different “ climate zones” inside the headlamp, where the lens is either warmed up by the light or cooled down by passing air.

When high air humidity and temperature differences exist between the inside of the headlamps and the outside, condensation can form on the inside of the lens, especially in cold and wet weather. The moisture in the headlamps can be compared with condensation on the windshield, which is cleared by the "defroster vent". This moisture buildup can happen for example: after a car wash, after steam cleaning of the engine or the front end, or after overnight temperature changes.

This condition is more easily visible with headlamps made from clear glass. The moisture is an *optical condition* which **does not** affect the headlamp function (light performance) and does not lead to corrosion nor does it lead to damage of the internal headlamp parts.

1. Remove the headlamps and dry the inside using compressed air or hot air blower.

2. Replace the headlamp ventilation hose for each headlamp with the new part number to help reduce any further humidity ingress into the headlamps (see Part information table below).

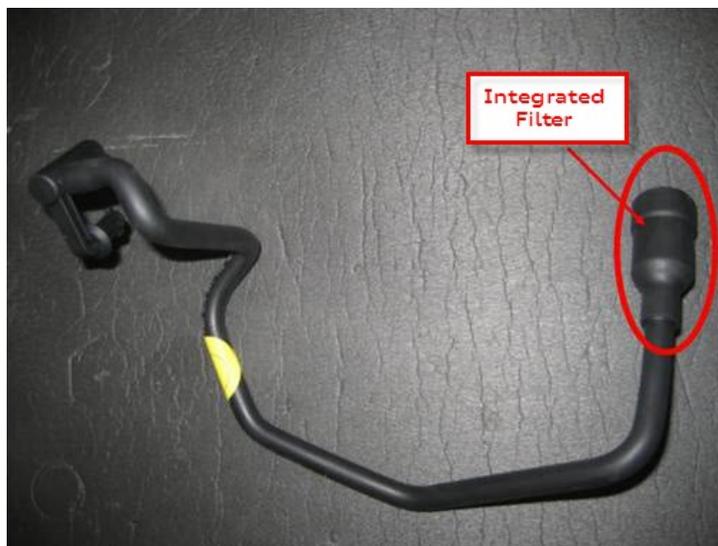
The modified ventilation hose can be recognized by the integrated filter as seen in Figure 2.

Figure 2. Ventilation Hose with Integrated Filter
