# Technical Service Bulletin

## 94 Rear side marker light inoperative in lower rear bumper

94 12 95 2029782/2 October 25, 2012. Supersedes Technical Service Bulletin Group 94 number 12-78 dated June 4, 2012 for reasons listed below.

Model(s)	Year	VIN Range	Vehicle-Specific Equipment
Q5	2010-2013	All	Not Applicable

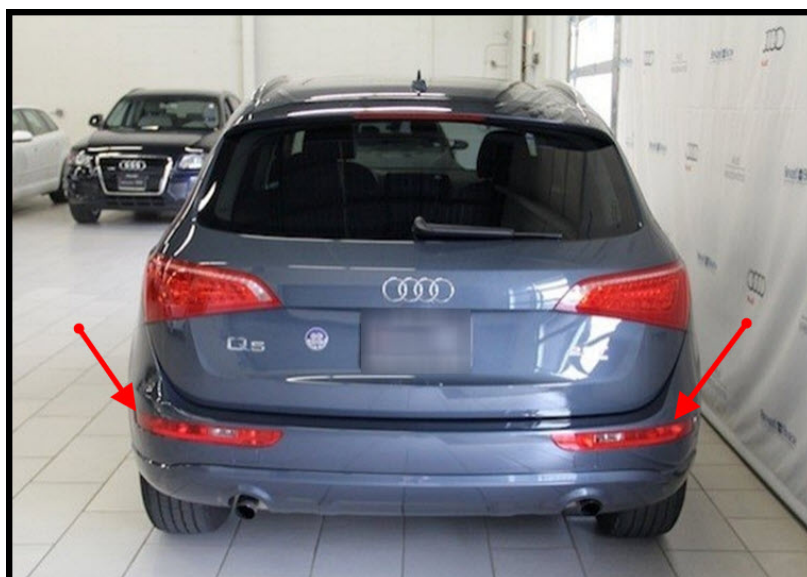
A “bulb out” warning is active in the instrument cluster’s Driver Information System (DIS) display and one or both of the rear side marker lights are burnt out.

Figure 1. Rear side marker lights.

Moisture and debris can enter into the lower taillight housing causing one or more of the bulbs to burn out.

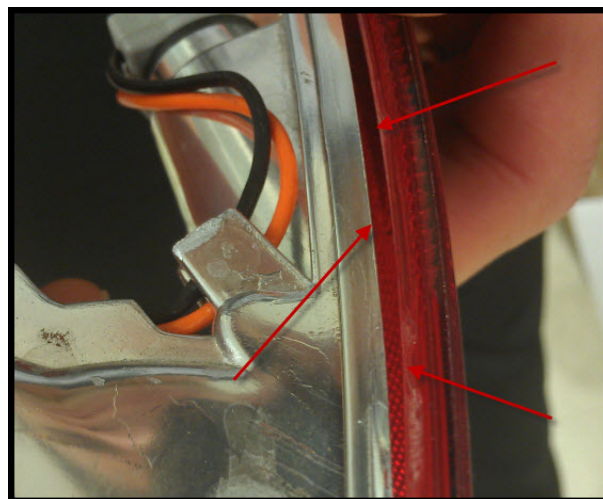
Inspect the lens for any separation around the red, reflecting edge of the taillight lens (Figure 2). Separation will take the form of a red color shade change along the seam. It may look more opaque than the rest of the perimeter.

*Figure 2. Taillight Lens separation.*

2. If there is any separation at all, then please replace the complete taillight housing. Keep the good bulbs and any wiring, and only replace the housing and any burnt out bulbs. Wipe all original, intact bulbs with alcohol prior to install, keeping any foreign matter, grease, oil from hands, etc. off of the bulbs.
