TECHNICAL BULLETIN

LTB00464NAS

'Camera Fault' Message Displayed

Range Rover Evoque (LV)

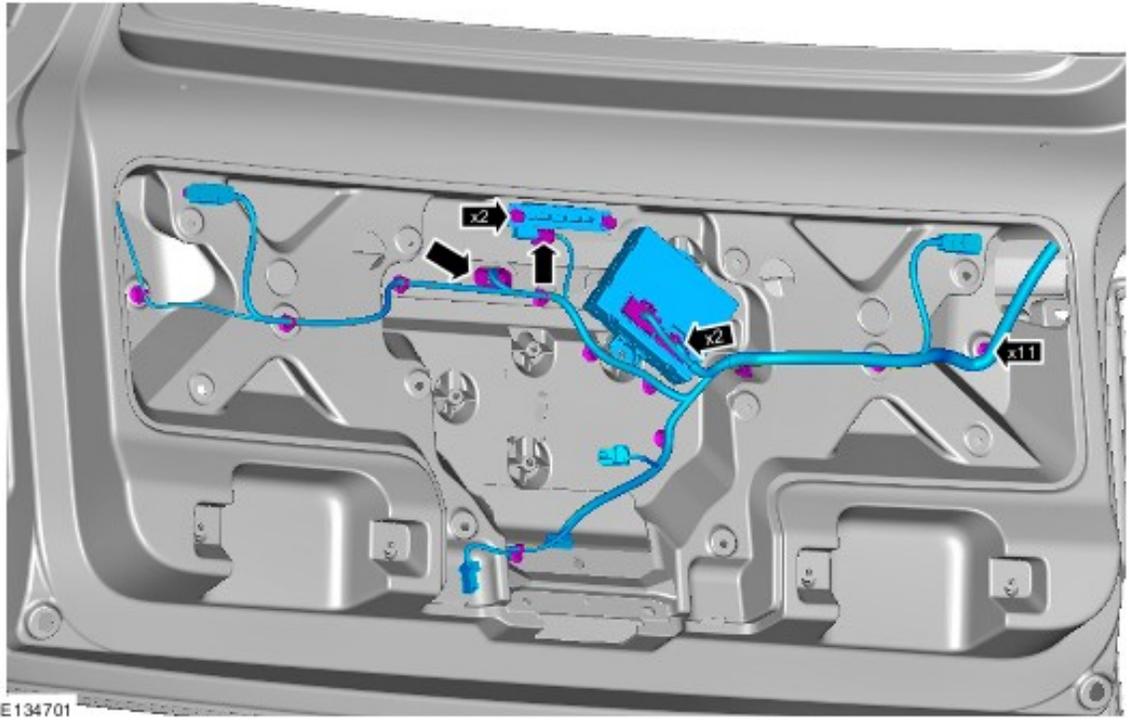
Cause: This may be caused by water ingress into the tailgate harness causing contamination of the camera connector.

5. Disconnect the electrical connectors.
- Remove the tailgate harness.
