# Technical Bulletin

Model(s)	Year(s)	Eng. Code(s)	Trans. Code(s)	VIN Range From	VIN Range To
Jetta Sedan	2012	All	All	AJ_CM402958	AJ_CM474080

90 12 02 November 5, 2012 2031334

**Instrument Cluster Clock and or Trip Buttons Inoperative**

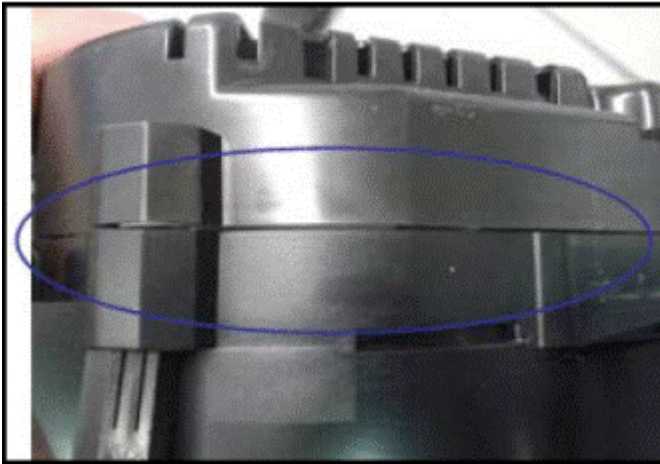
Since the lower housing does not fit properly with the upper housing, the buttons do not make contact when time and/or trip meter is being set.

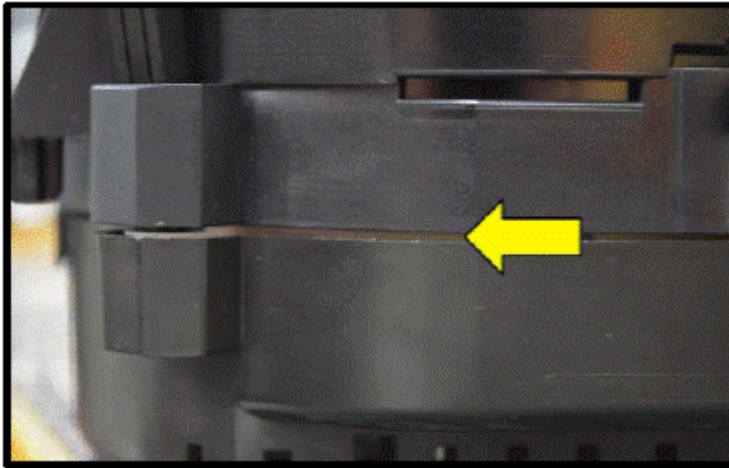
- With the instrument cluster removed from the vehicle inspect the seam between the two instrument cluster halves <arrow>.
