Service Bulletin

Bulletin No.: PI0842

Subject: Trunk Trim Panel Below Rear Package Shelf Loose/Sagging /Bowing at Rear

Models: 2013 Cadillac XTS

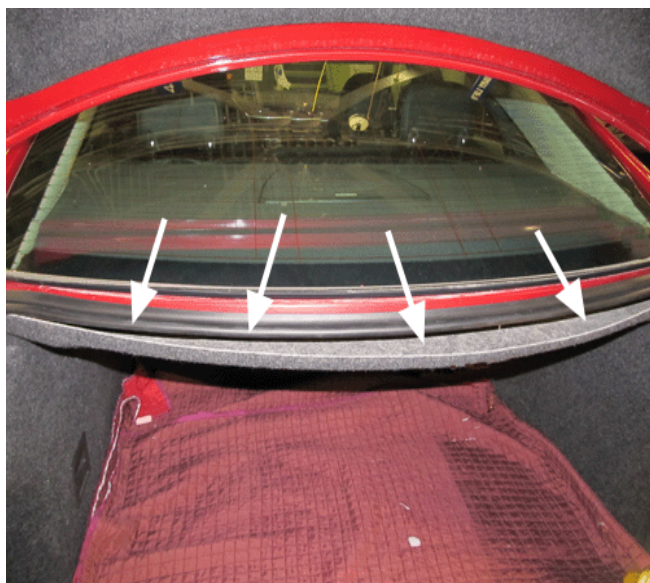
2964028

Some customers may comment that the trunk trim panel below the rear package shelf is loose, sagging or bowing at the rear.

The cause of this condition may be that the trim panel may have a loose interface to the rear package shelf underside sheet metal.
