# Service Bulletin

Bulletin No.: PIC5729

**Subject:** Squeak Noise Heard When Turning Steering Wheel

**Models:** 2013 Cadillac ATS  
Built Prior to VIN 1G6DL1E33D0115038

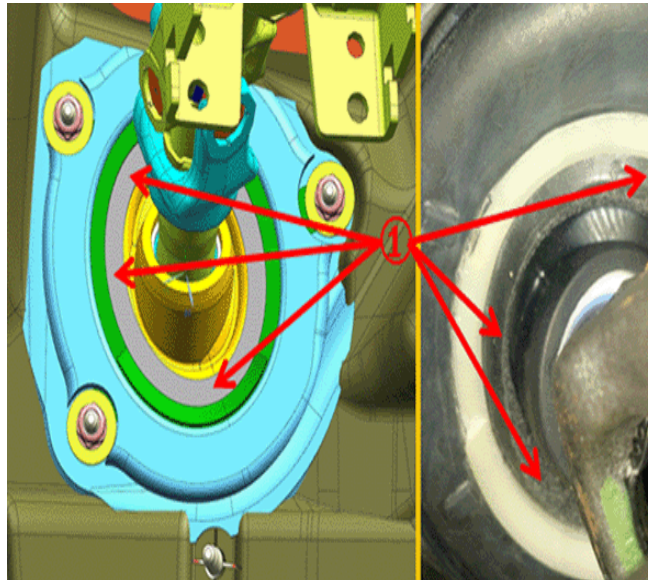
2907573

A squeak noise may be heard in the left dash area when turning the steering wheel and only when the column is raked to the full down position. This noise is dependent on the column's rake position and for this reason could be perceived as intermittent if the column is not fully down when attempting to duplicate the noise. The squeak is caused by the exposed Mylar adhesive backing from the acoustic foam seal contacting the intermediate shaft (I-shaft) as the shaft rotates with the steering wheel.

2. Pull out the acoustic foam (1) shown above and discard.
3. Reinstall the close out panel.
