Service Bulletin

Bulletin No.: PIP4775B

Subject: SES Light Due To P2181 DTC - Inspect Rear Heater Operation And Hose Installation

Models: 2010 - 2013 Chevrolet Express Cutaway
2010 - 2013 GMC Savana Cutaway
with a Bus Body, V8 Gas Engine, and Rear Heat Provisions (RPO ENC)

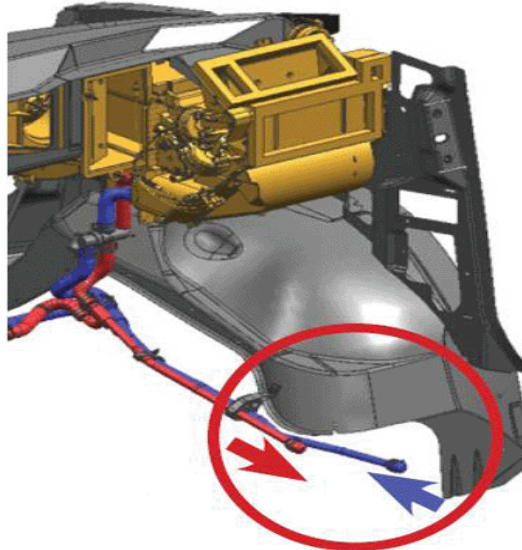
2408820

If this concern is encountered, inspect the rear heater pipes shown below for proper installation.

The longer, outboard pipe shown in blue is the coolant return from the rear heater. The shorter, inboard pipe shown in red is the coolant supply to the rear heater.

If the connections are reversed, install them correctly and re-evaluate the concern.
