Service Bulletin

Bulletin No.: PIE0235

Subject: Engineering Information – Side Door Weatherstrip and Seal Fit/Appearance Concerns

Models: 2012-2013 Chevrolet Sonic

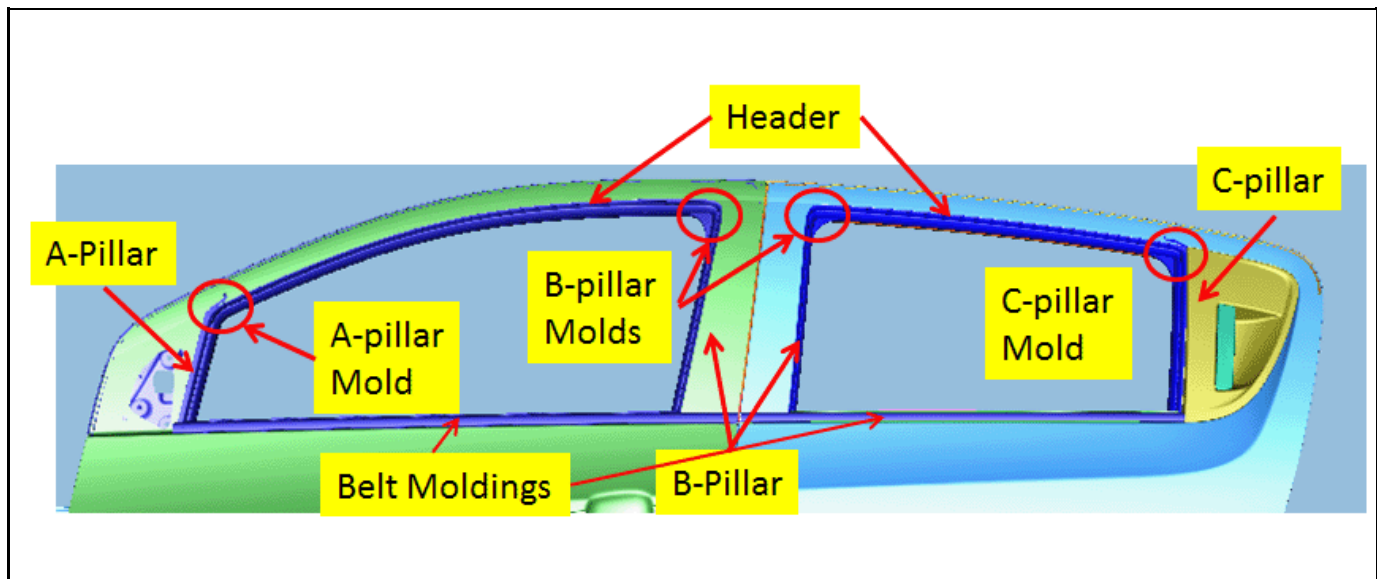
Some customers may comment that the side door weatherstrips and/or outer sealing strips (belt moldings) do not look like they are properly seated, are deformed or not installed correctly. The components involved in this EI include the side door glass run channel, belt moldings, primary and secondary seals.

1. Inspect the vehicle and determine the cause of the customers concern. DO NOT correct the condition.
2. Using the below graphics, identify the component and document the concern. Use the descriptions in the graphics.
