# Service Bulletin

Bulletin No.: PIC5758

**Subject:** Paint Chipped Under Luggage Rack Roof Rails

**Models:** 2010 - 2011 CTS Sport Wagon  
Built Prior To September 12, 2011

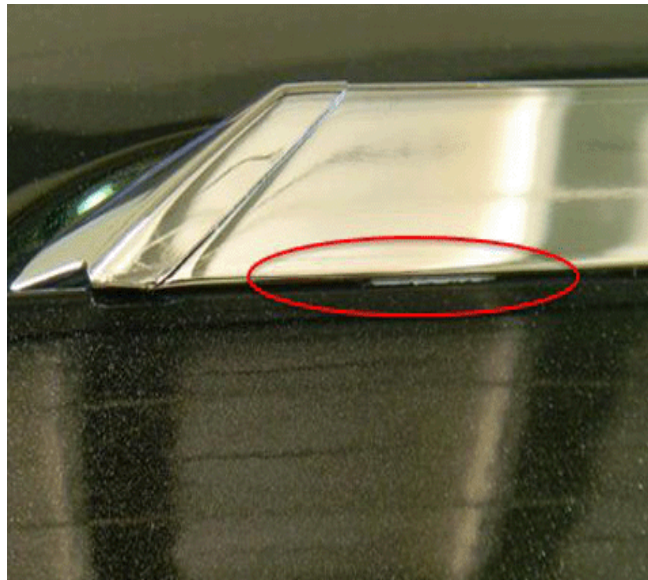
2912484

Customer may comment that paint on roof may appear chipped under the vehicle's Luggage Rack Roof Rails. This concern is due to the rail's seals allowing the Luggage Rack Roof Rails to contact the vehicle's roof.

Reference the attached photo for area of concern:

Replace both Luggage Rack Roof Rail Assemblies using current listed part numbers. Replacement assemblies have improved seals to prevent this concern. Repair paint on vehicle's roof as necessary.
