Service Bulletin

Bulletin No.: PIC5735A

Subject: Rattle Or Buzz From Behind IP IPC Or Dash

Models: 2013 Chevrolet Malibu
Equipped with 2.5L L4 Engine (RPO LCV)

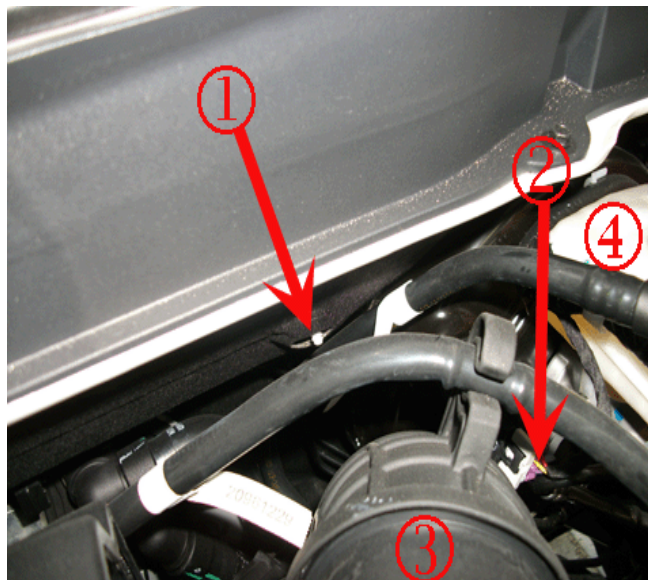
Vacuum pipe contact.

1. Vacuum pipe contact with bulkhead and stud.
2. Vacuum pressure switch connector.

- 3. Intake snorkel.
 - 4. Brake master cylinder.
- Intake resonator and snorkel removed.

Inspect the plastic vacuum tube that supplies vacuum from the pump to the vacuum switch and brake booster. If either plastic tube is contacting the bulkhead, stud or brake lines continue with this repair. The vacuum pipe has likely been routed over the top of the throttle body and sensor during assembly. Remove the intake resonator and snorkel as shown below. Carefully flex the vacuum pipe rearward and off the throttle body and TPS. Pictures below indicate correct and incorrect routing. It may be necessary to wrap the brake booster vacuum switch with butyl tape if it is contacting a vacuum pipe. It may also be necessary to wrap the rubber section of the brake vacuum pipe with butyl tape if it is contacting a brake line or body of brake booster. See photo below for position of butyl tape on pipe. Check the position of pipe clamps for contact with brake booster or brake lines and reposition as needed.

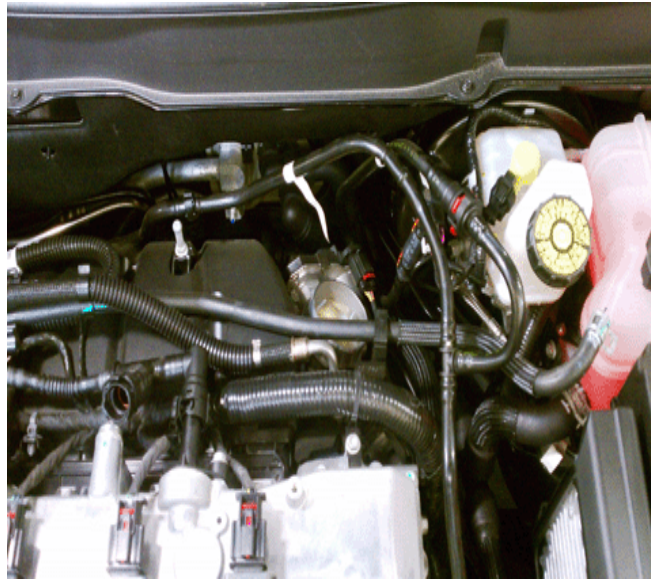
2911056

Throttle body vacuum pipe routing incorrect.

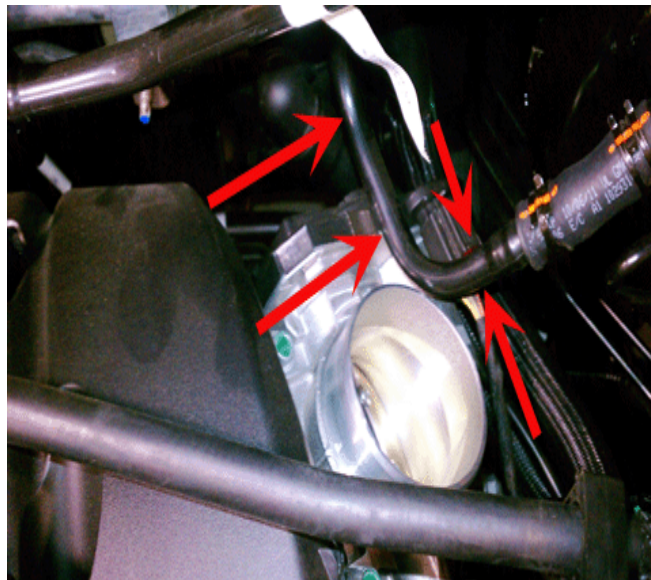
2911055

Throttle body vacuum pipe correct routing.

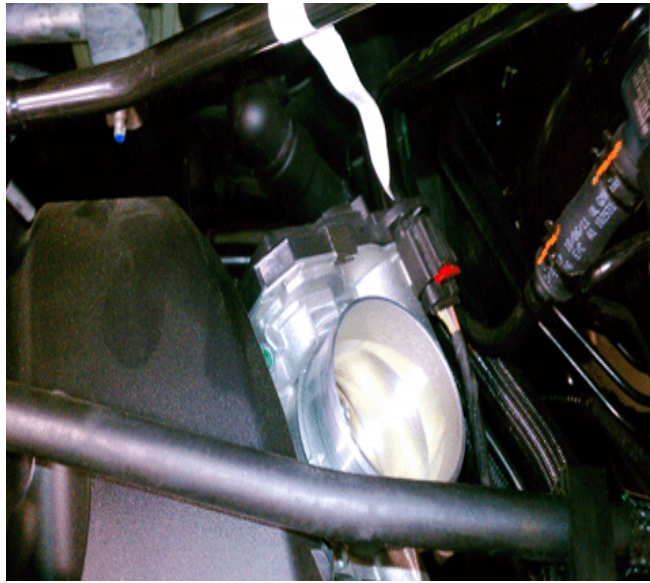
2911054

Butyl tape installed on vacuum pipe.
