Service Bulletin

Bulletin No.: PIC5736A

Subject: Inner Door Trim Panel Squeak Noise

Models: 2013 Cadillac ATS

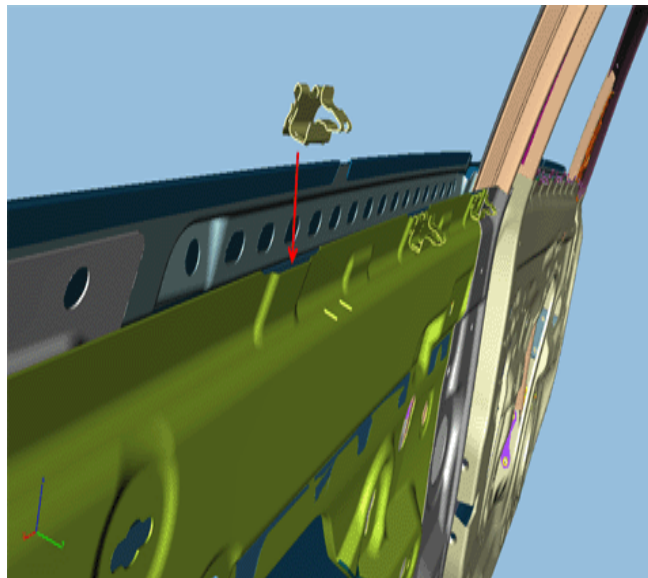
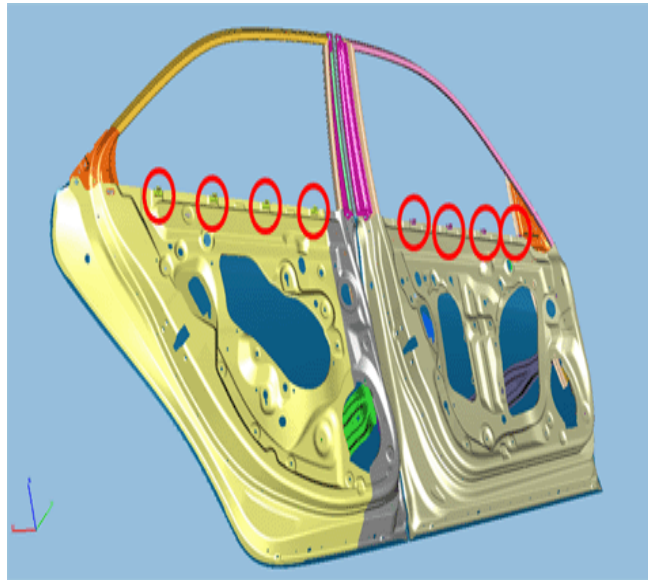
2911982

The interior door trim panel may exhibit a squeak or creak noise when pressing down on the top of the door trim panel (such as might occur when resting one's arm on the door trim). The noise is caused by non-coated door clips.

Note: There may be felt on the door and/or window inner sealing strip. The felt can be left in place for both locations.

2. Replace the clips (4 per door) with the dull finish clips provided through WPC.
3. Reinstall the interior door trim panel by referencing the appropriate Side Door Trim Replacement procedure in SI.
