Bulletin No.: PIC5757

Service Bulletin

Subject: Blower Motor Inoperative and/or Water In Blower Motor Control Module Area DTC B0193

Models: 2013 Chevrolet Malibu eAssist

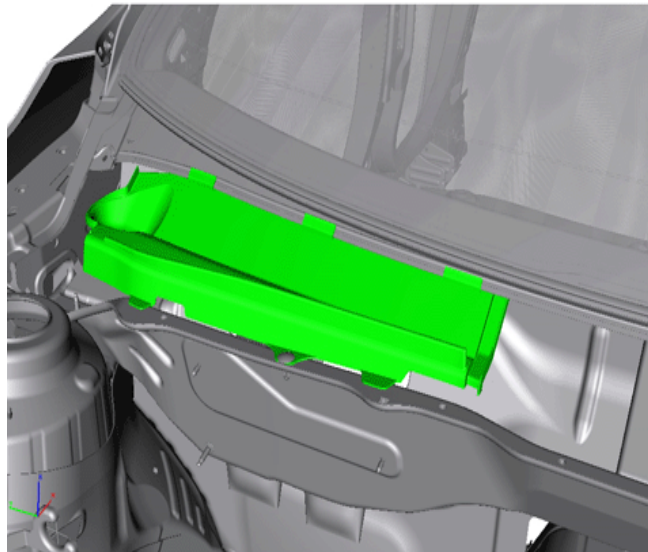
2919801

A customer or technician may indicate the blower motor is inoperative and/or there is water in the blower control module motor area. DTC B0193 may also be set.

If this concern is duplicated inspect the blower motor, blower motor control module and connectors for signs of water. If water is found it will be necessary to reseal the plenum deflector (see images below) and then replace parts and repair connectors as needed. Remove the air inlet grille to access the plenum water deflector.
