Service Bulletin

Bulletin No.: PIP5066

Subject: Engine Overheat or Cooling Fans Inoperative

Models: 2013 Cadillac ATS

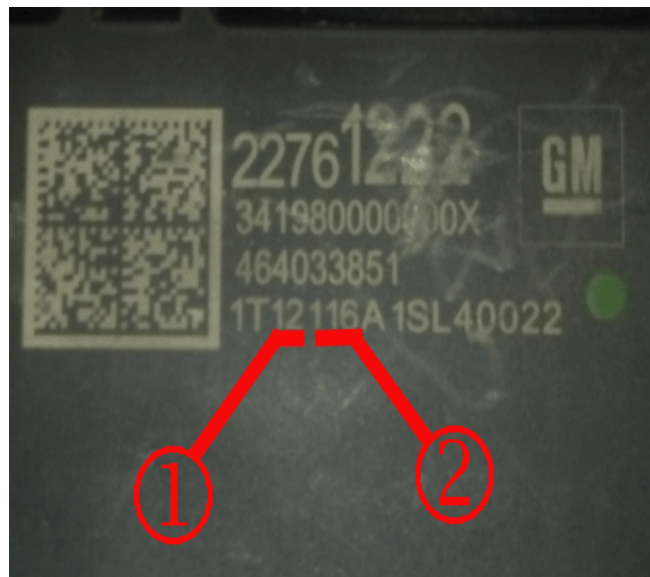
2915185

This may be the result of a concern with the Cooling Fan Control Module.

First verify if the Cooling Fan Control Module has a suspect date code (Refer to picture below).

Any date code less than 12207 (23JUL12) is suspect.

If the Cooling Fan Control Module is suspect then use the service scan tool and procedure below to perform a system check on the Cooling Fan Control Module.

If the electric cooling fan stops working then replace the Cooling Fan Control Module:
