# UPDATE Technical Bulletin

91 12 21 October 02, 2012 2031133

UPDATE – 91J7 RCD 510 (Premium 8) Radio Software (U.S. Only)

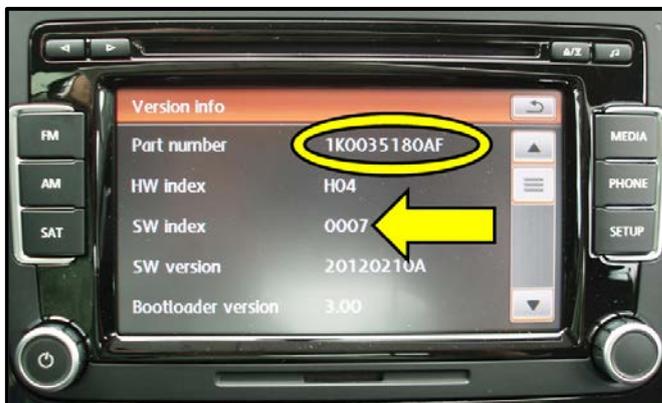
⇐ Verify current part number is **1K0-035-180-AF** <circle>

⇐ Verify current SW index is “0007” <arrow>

Tip: If SW index is “0008”, no update required.

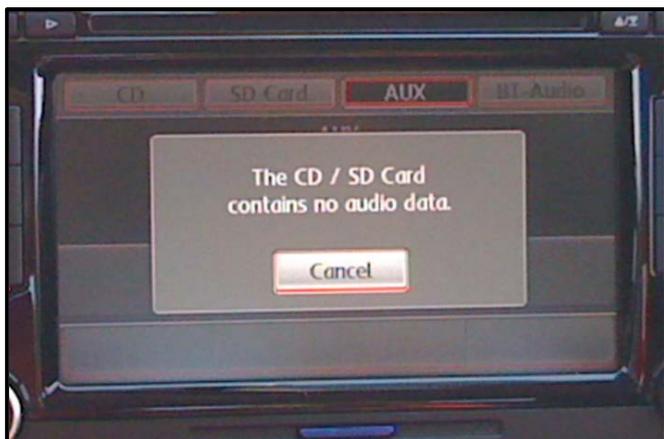
If a message “The CD/SD Card contains no audio data” <as shown appears when SD card is inserted, repeat previous steps due to adaptation not correct.

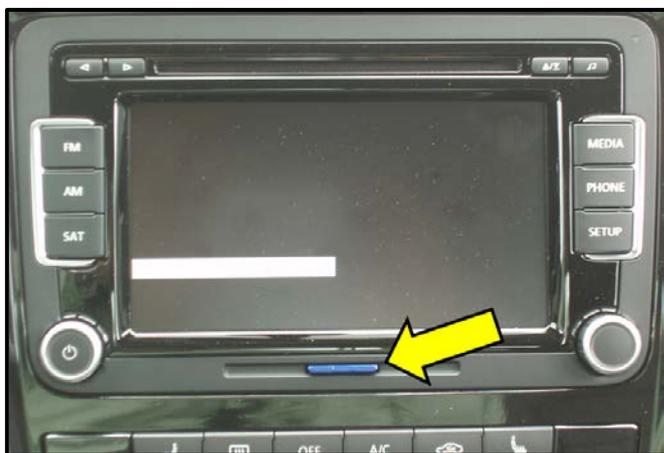
Software level 0008 can ONLY be used on non-hybrid cars that are starting at Software level 0007. Using this Software Level 0008 on the wrong unit **WILL CAUSE IRREVERSIBLE DAMAGE** and result in a necessary radio replacement. Installing this Software Level 0008 on the wrong unit is NOT COVERED under this action.

⇐ Insert the SD card# PREM8 RADIO SW08 into the SD card slot on the radio as shown <arrow>.
