Technical Bulletin

Model(s)	Year	Eng. Code	Trans. Code	VIN Range From	VIN Range To
Passat	2011-2012	All	All	A3_BC000001	A3_CC025567

40 12 05 October 15, 2012 **2028353** Supersedes V401201 dated January 19, 2012 to include nut and bolt replacement part numbers.

Front Suspension Creaking Noise

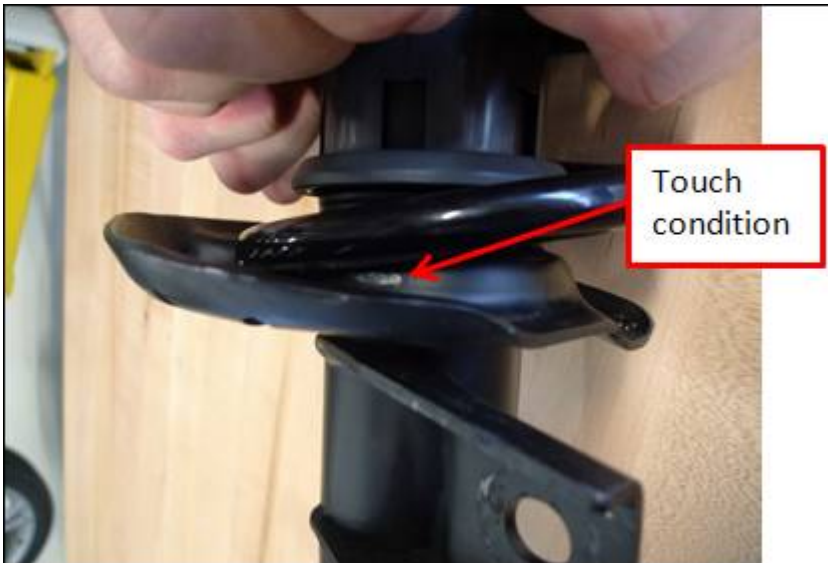
Figure 1

Coil Spring is not formed correctly and rubs against the perch of the strut.

- Verify if a car with the creaking noise has the contact mark (on one side or on both sides) as shown in figure 1.

- Remove affected suspension strut and disassemble, see Repair Group 40 in ElsaWeb.
- Apply touch up paint to the contact area of the strut perch and allow required drying time.

Use Rustoleum Cold Galvanizing Compound # V2185838 (or similar obtained locally), 2 coats.
Cover with Rustoleum Flat Black Spray Paint # V2178838 (or similar obtained locally), 1 coat.

- Install new spring on suspension strut (per vehicle PR-codes).
- Install suspension strut, see Repair Group 40 in ElsaWeb.
