# Technical Bulletin

Model(s)	Year	Eng. Code	Trans. Code	VIN Range From	VIN Range To
Beetle	2012	All	All	AT_CM000001	AT_CM625537

63 12 01 December 14, 2012 2032093

### Paint Chafe between Front Bumper Cover and Fender

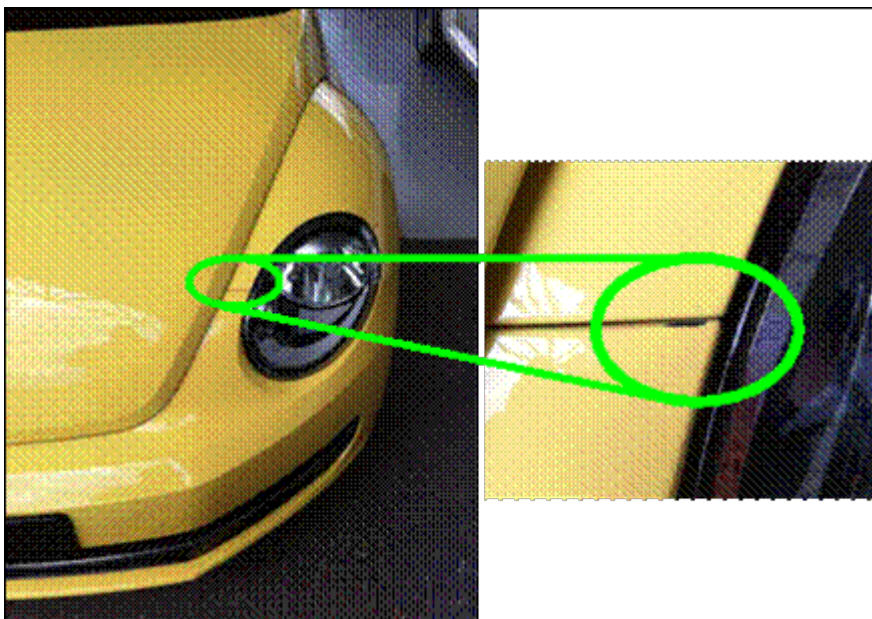
Figure 1

Customer may identify a paint chafe due to the misaligned between bumper cover and fender (quarter panel, See Figure 1.).

Paint chafe condition

Contact friction between front bumper cover and fender.
