MODEL
Sorento (XM) 2.4L
GDI 2013MY

NUMBER
126 [Rev 1, 12/11/12]

TECHNICAL SERVICE BULLETIN

SUBJECT: ALTERNATOR PULLEY AND TENSIONER REPLACEMENT

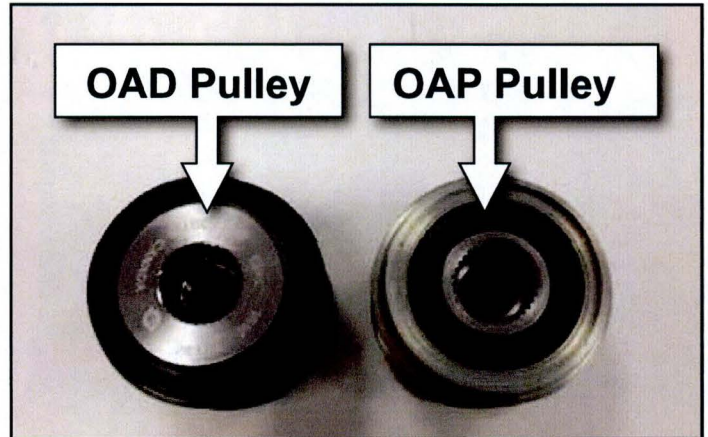
2. Inspect the alternator pulley to confirm the specific type of pulley installed on the vehicle. If the vehicle is equipped with the Original Alternator Dampening Pulley (OAD) (see identification chart below), perform the procedure outlined in this TSB.

Pulley Identification Chart	
Pulley Type	Body Color
OAD	Black
OAP	Silver

If the vehicle is equipped with the Overrunning Alternator Pulley (OAP), proceed with re-flash procedure only.
