Service Bulletin

Bulletin No.: PIT5072B

Subject: Power Lift Gate Does Not Stay Fully Open Or Drifts Down A Few Inches

Models: 2010 - 2012 Chevrolet Equinox
2010 - 2012 GMC Terrain

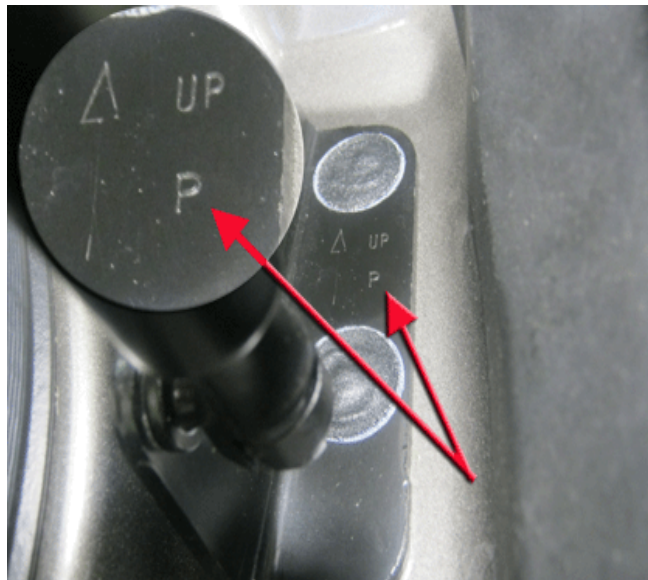
2598278

This may be caused by the incorrect strut mounting brackets installed on the vehicle. Check on the lift gate mounting brackets for a letter P or M stamped on the bracket. P is for power lift gate and M is for Manual lift gate. If Manual strut mount brackets are found on the vehicle replace with the correct bracket(s) for power lift gate.

The picture above is an example of the correct brackets for a power lift gate.
